ENGINEERING ASSESSMENT REPORT

**Westchester Lake Dam
(NYS DEC File No. 213-
0412)
Town of Cortlandt
Westchester County,
New York**

October 16, 2015

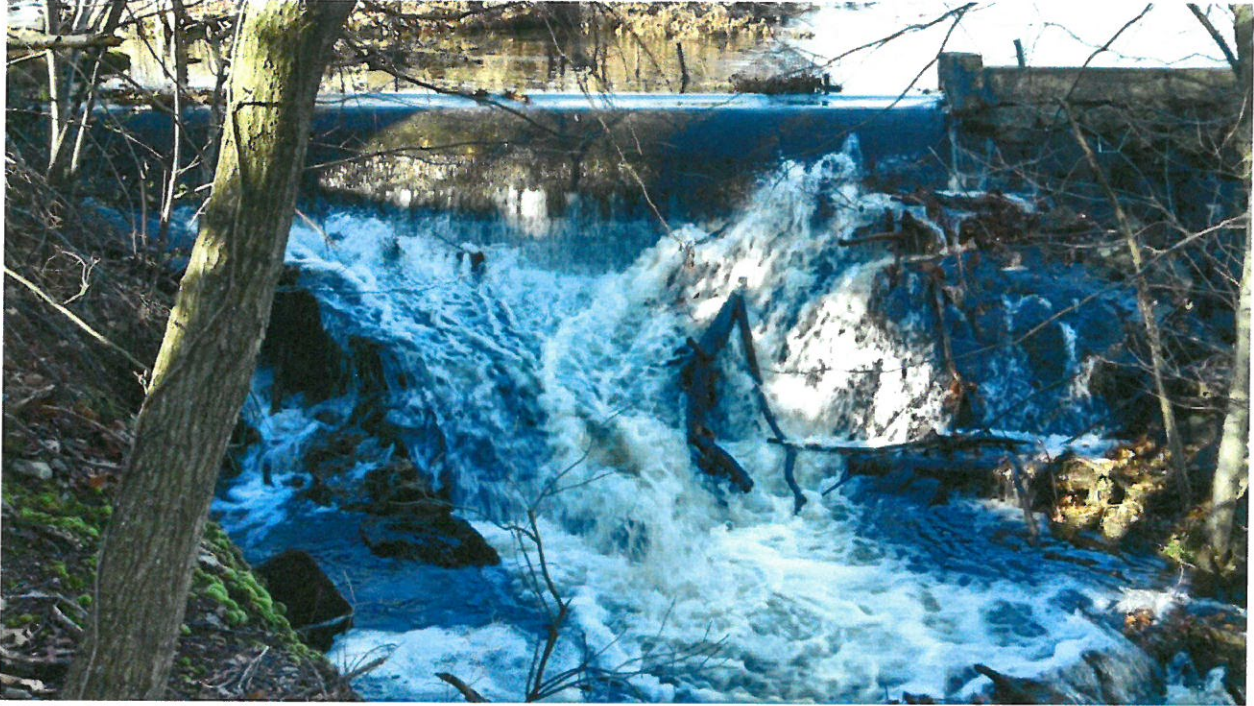
Photo 1: Dam Spillway

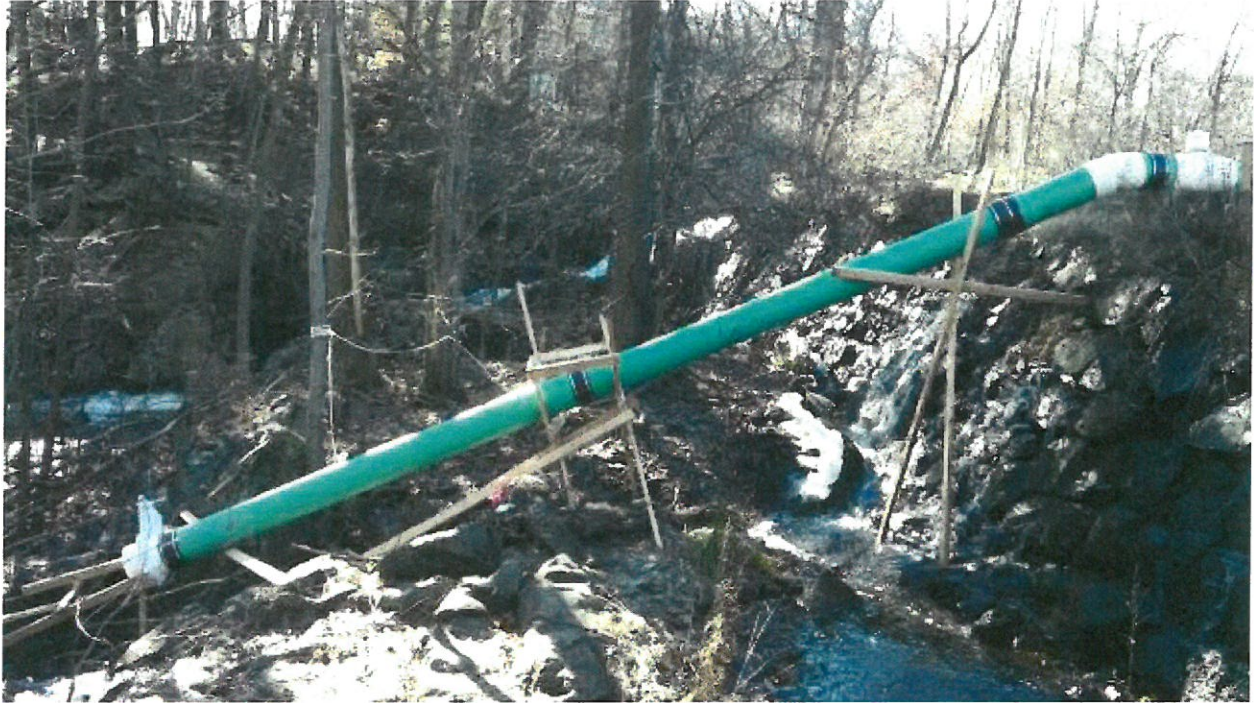
The 2015 dam safety inspection revealed significant seepage, erosion, and vegetation along the left abutment, the entire downstream face, and the foundation/toe area of the dam. Based on comparisons with previous inspections, the seepage appears to have significantly increased as a result of ongoing deterioration of the masonry structure. Low level outlets, once capable of draining the dam for maintenance or to mitigate emergencies are inoperable and/or broken.

Photo 3: Front of Dam (Seepage through face of dam. Temporary piping installed to drawdown water level of the dam.
