Re: DEC/SEQRA  
Cortlandt MOD/Evergreen Manor Development  
2003 Crompond Road, Cortlandt, Westchester County  
18PR08018

Evergreen Manor Project  
Alternative Analysis

Re: Evergreen Manor Project Specifically Former Evergreen Manor Hotel

## **Former Evergreen Manor Hotel (Photos 1- 31)**

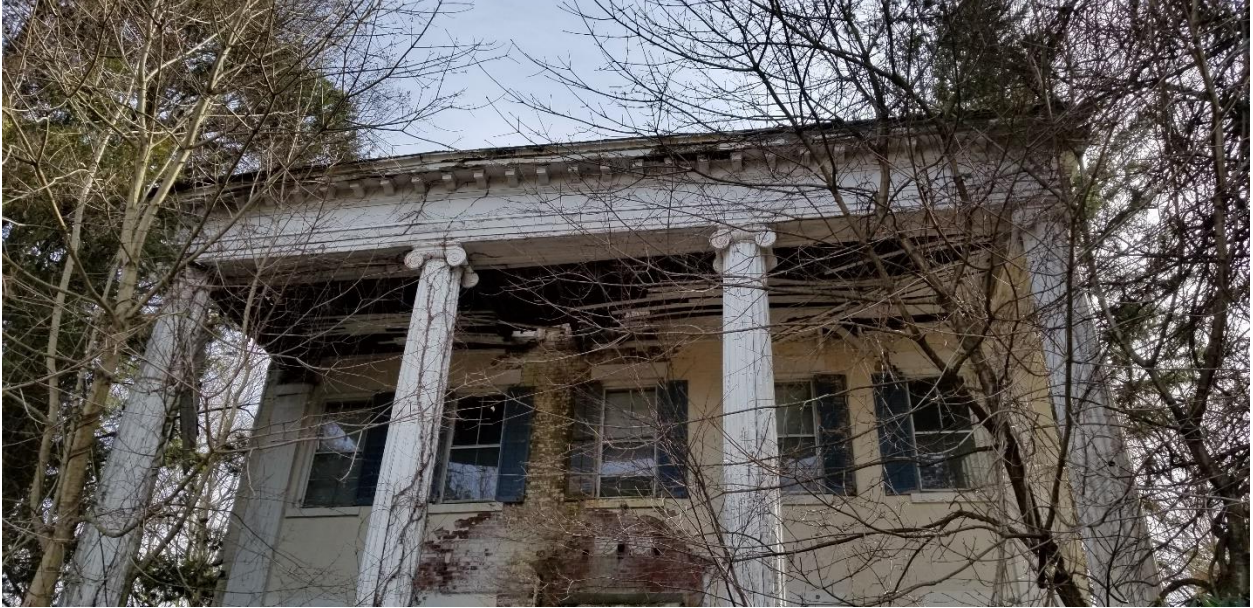
The wooden covered porches located on the western, southern and eastern sides of the building have failed and collapsed. The columns on the northern side of the building have apparent rot. These elements would require removal and replacement. Roofing systems over the main portico along the front (north) elevation would also need to be removed and replaced. Decorative elements at the front entry of the structure have been removed. Portions of the floor at the entry vestibule have collapsed.

3. Deterioration of portico roof at front (north) elevation

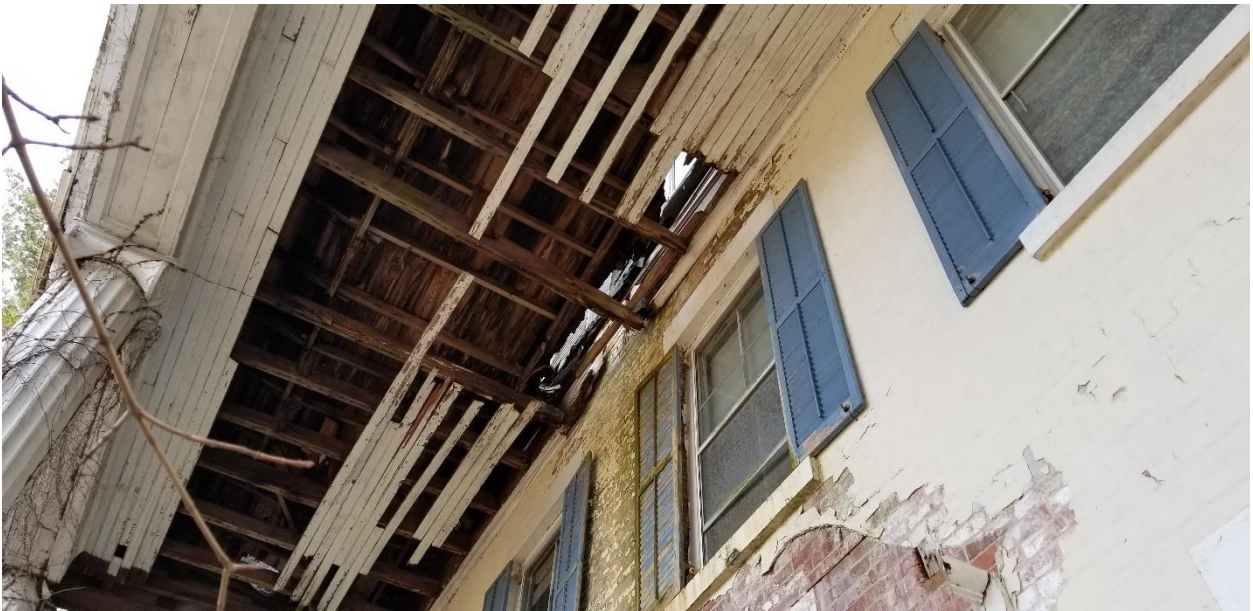
4. Deterioration of portico roof at front (north) elevation

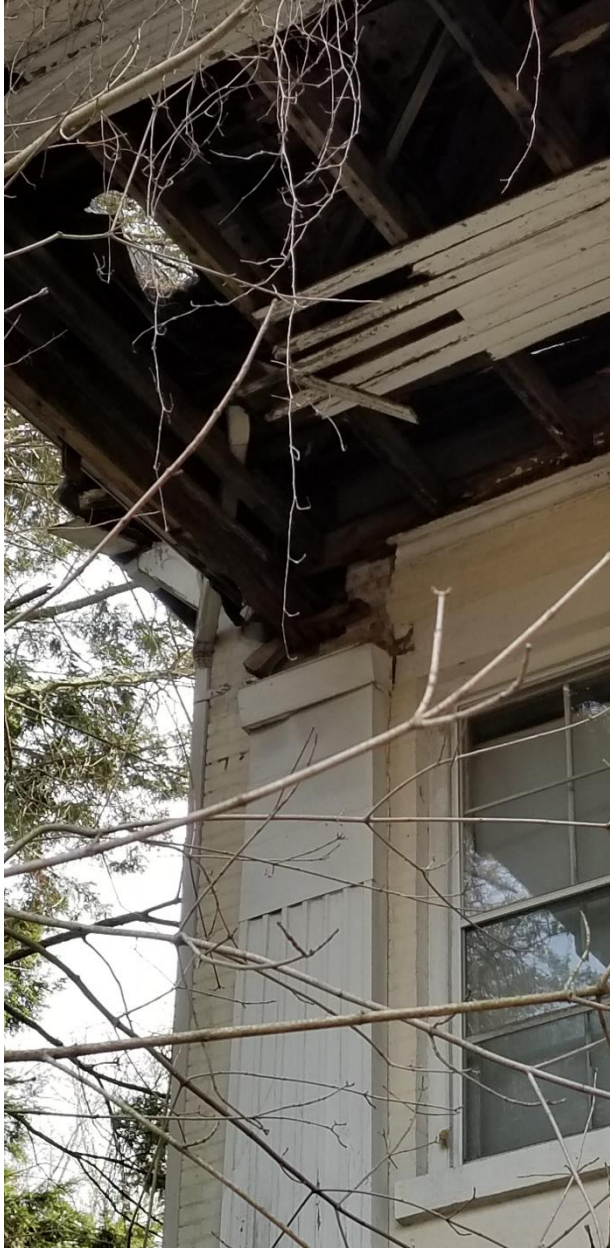
5. Deterioration of portico roof at front (north) elevation

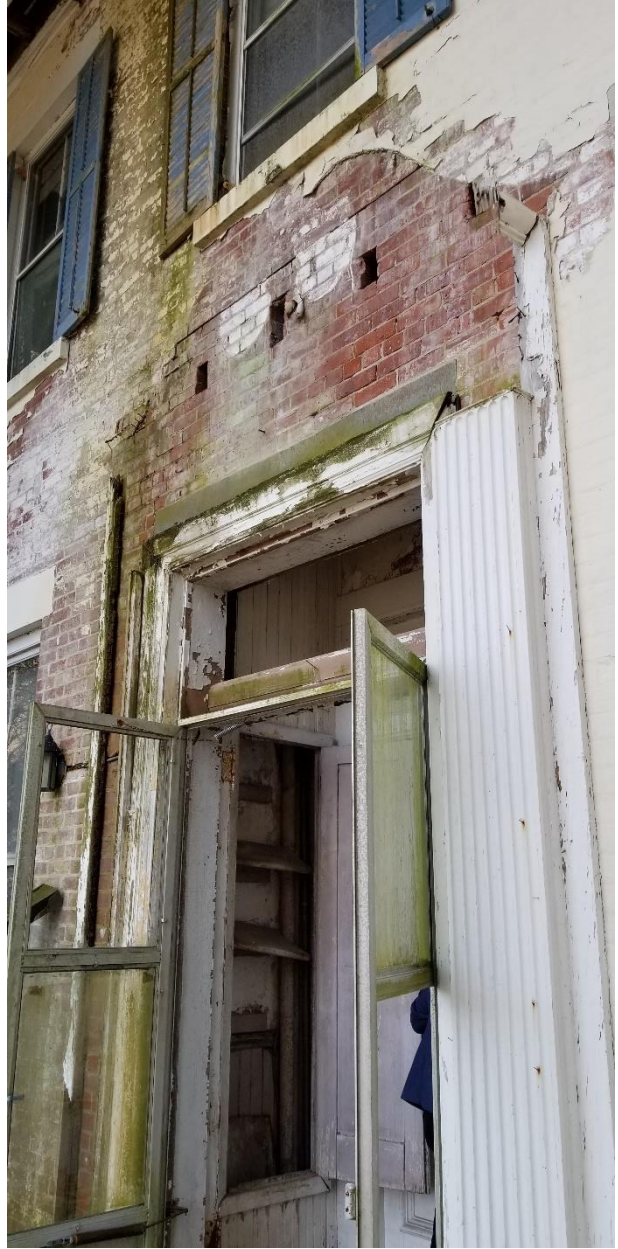
6. Missing decorative elements at front door

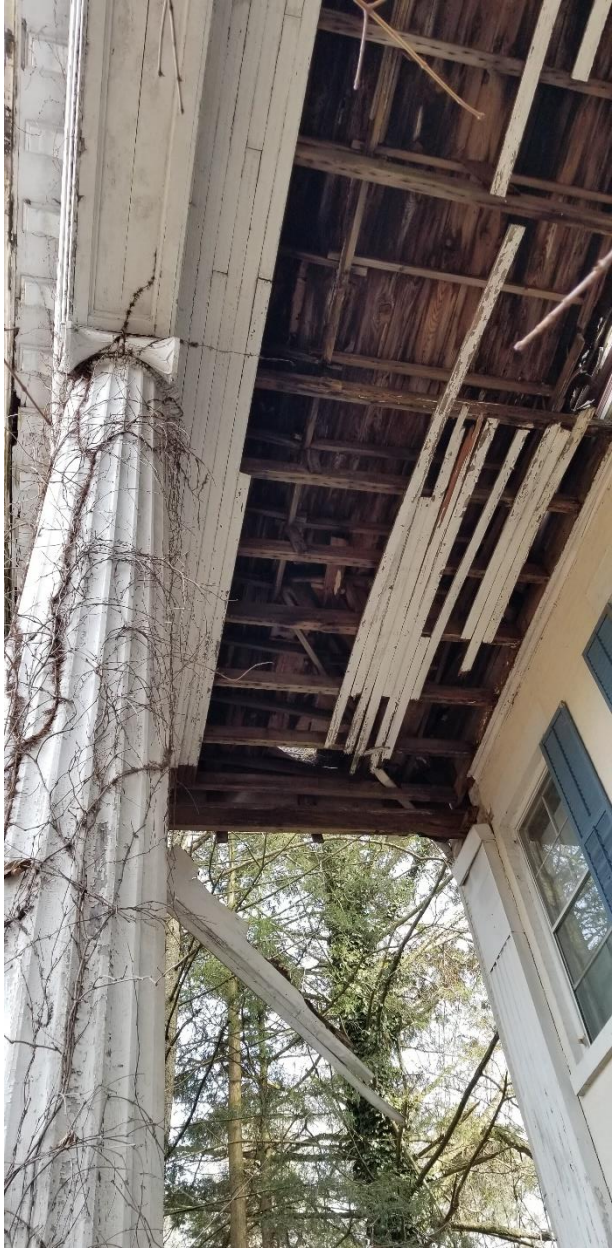
7. Deterioration of portico roof at front (north) elevation

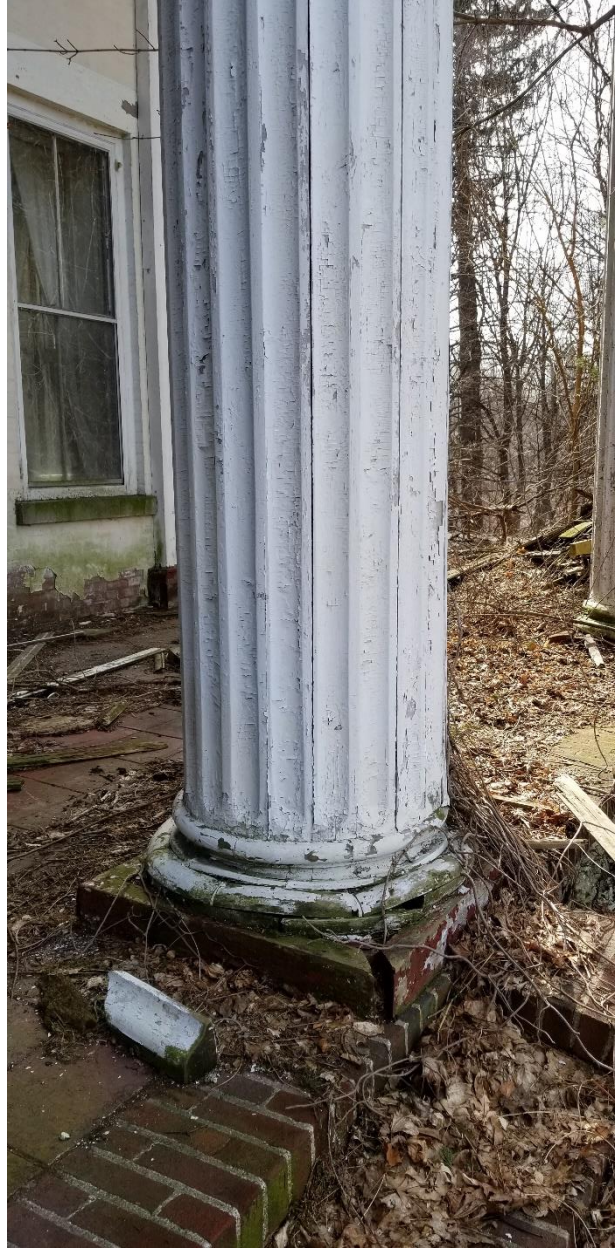
8. Deterioration of column base at front (north) elevation

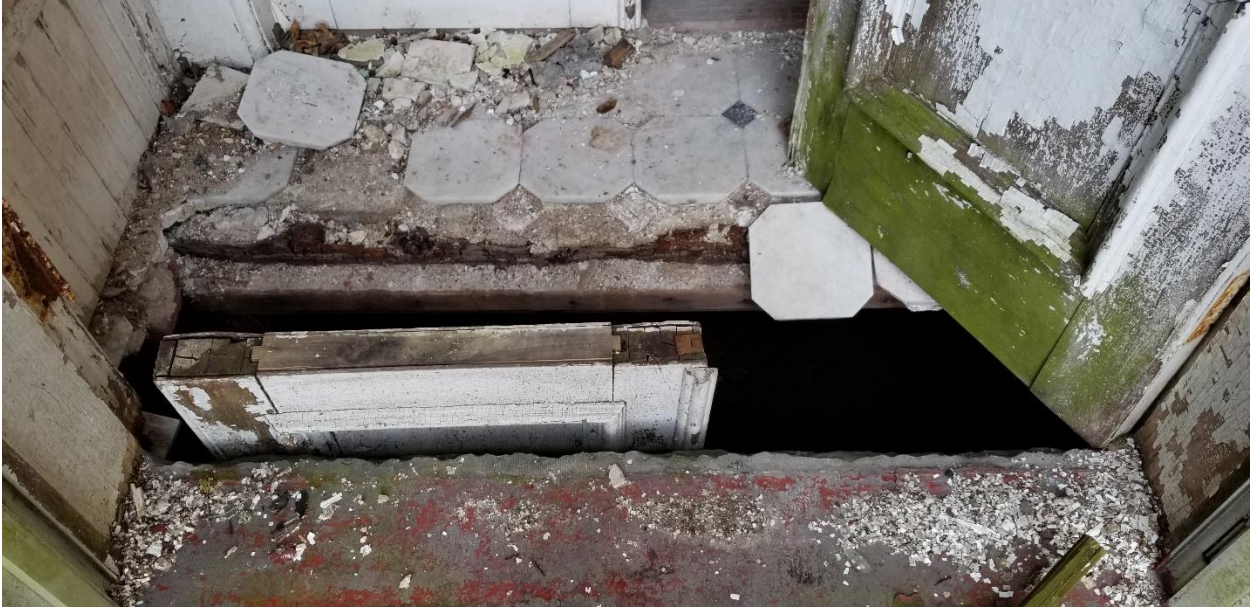
9. Portion of missing floor at main entry vestibule

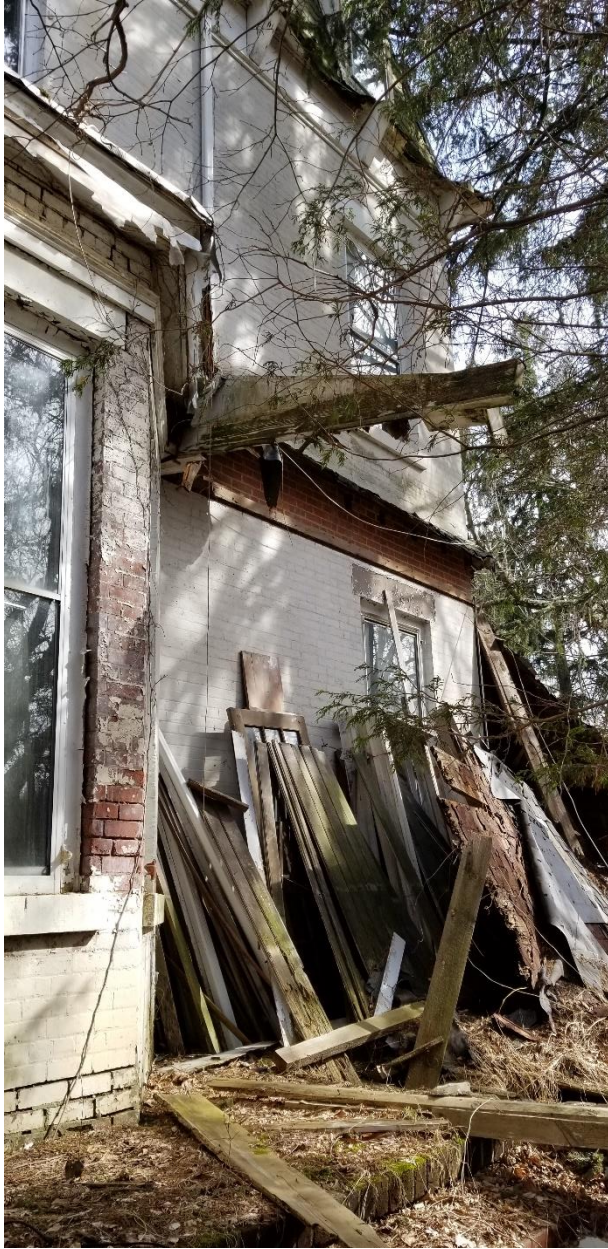
10. Collapsed porch roof on west elevation;  
debris

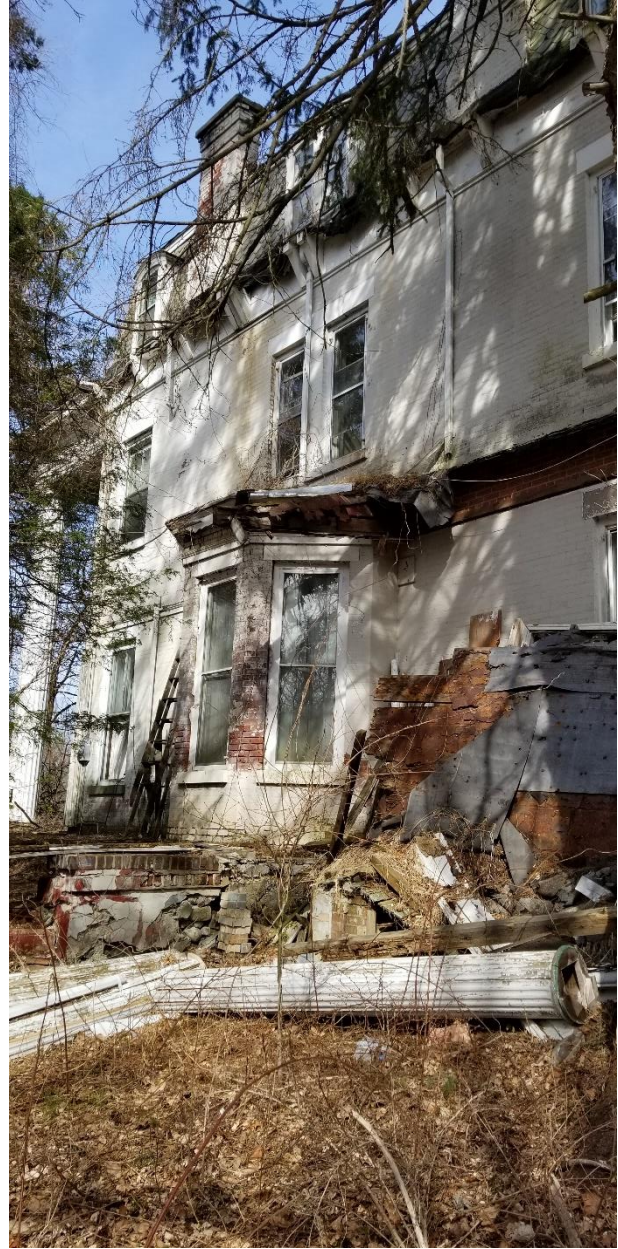
11. Collapsed porch roof on west elevation;  
damage to roof over window bay

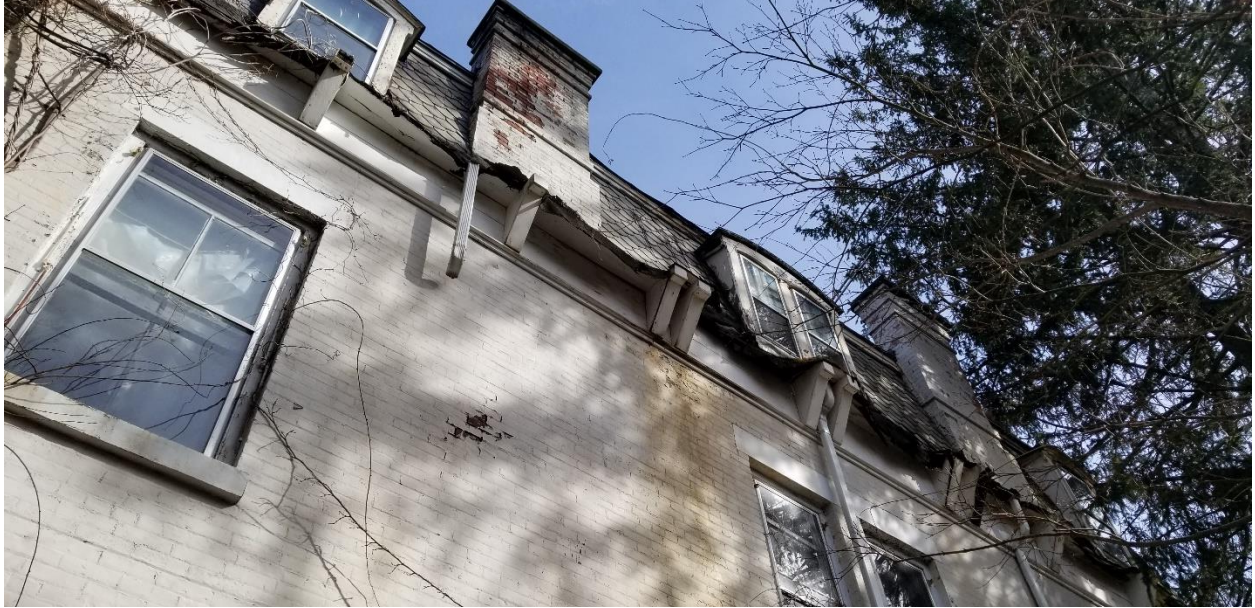
12. Deterioration of cornice

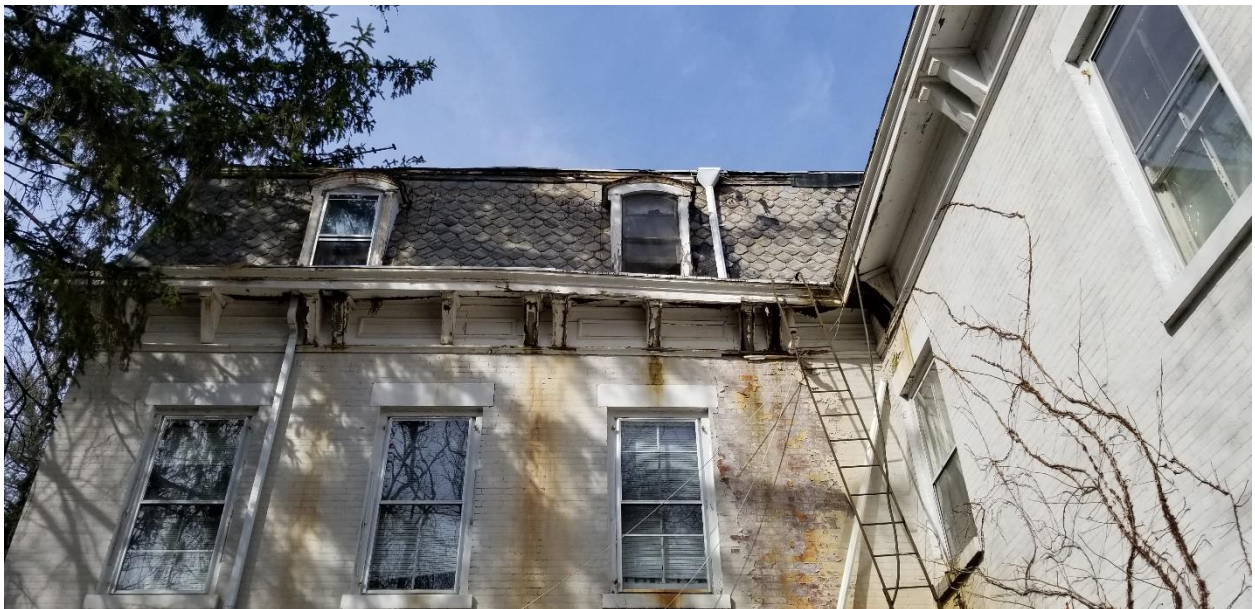
13. Deterioration of cornice and roof shingles; failure of gutter system

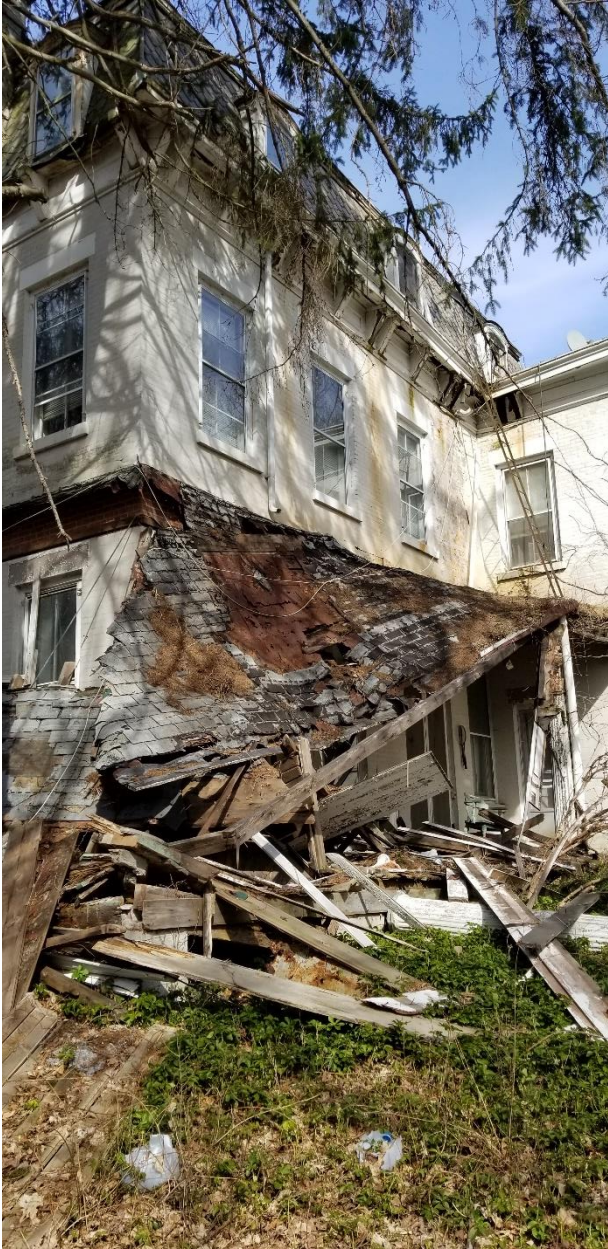
14. Collapsed porch roof on south elevation with debris

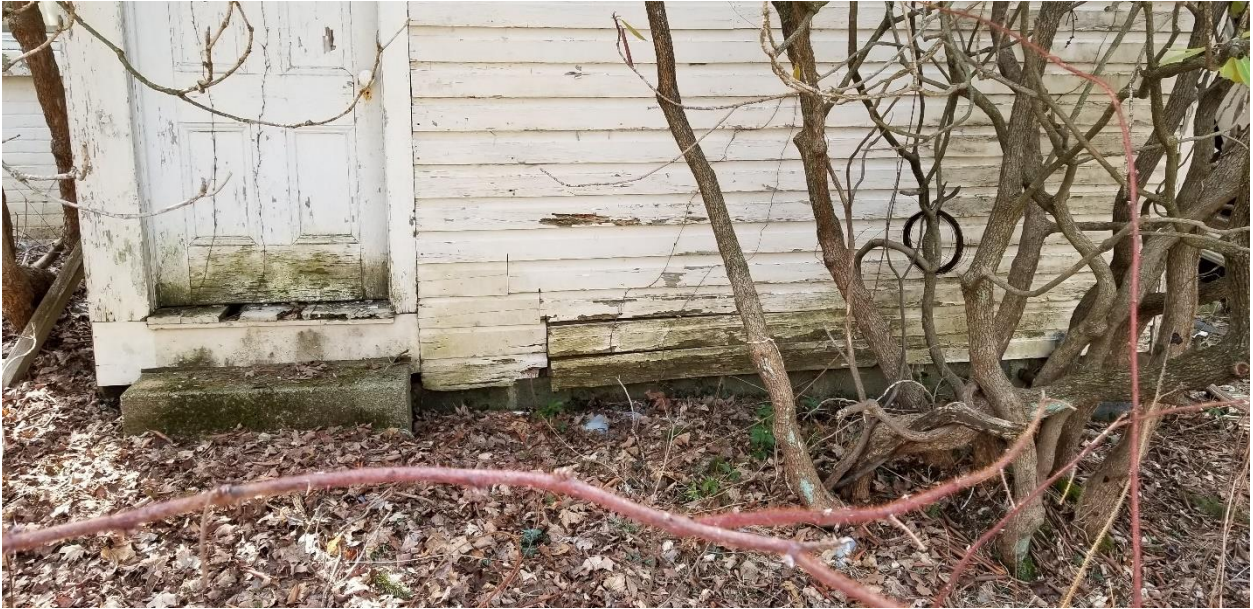
20. Deterioration of building addition area on southeast portion of structure

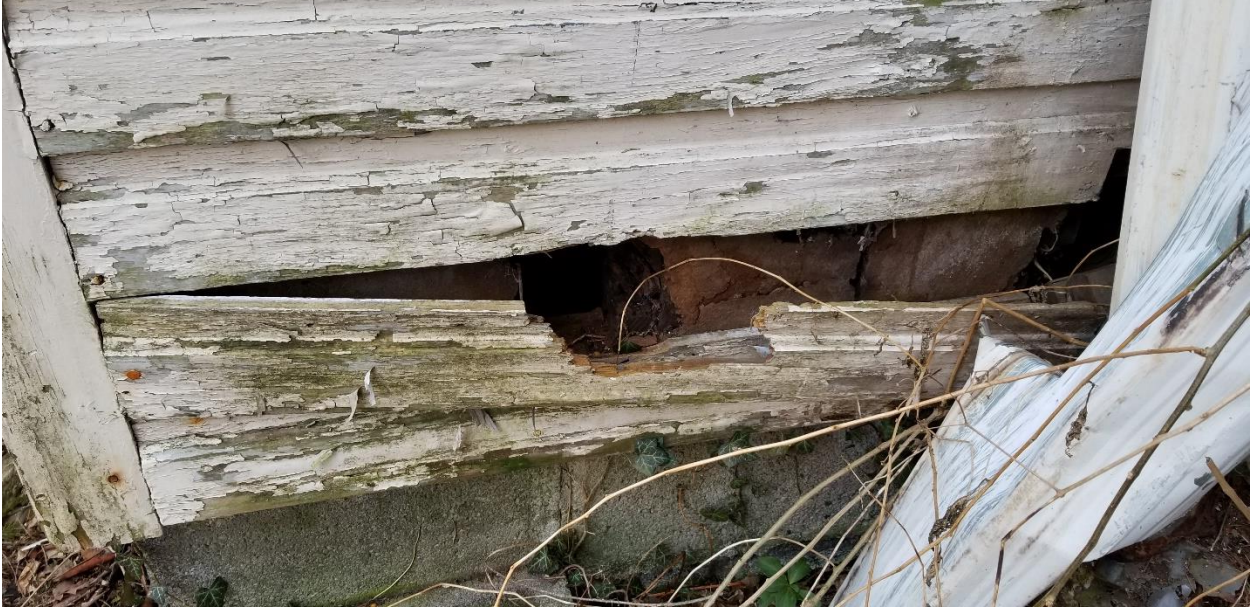
21. Deterioration of building addition area on southeast portion of structure

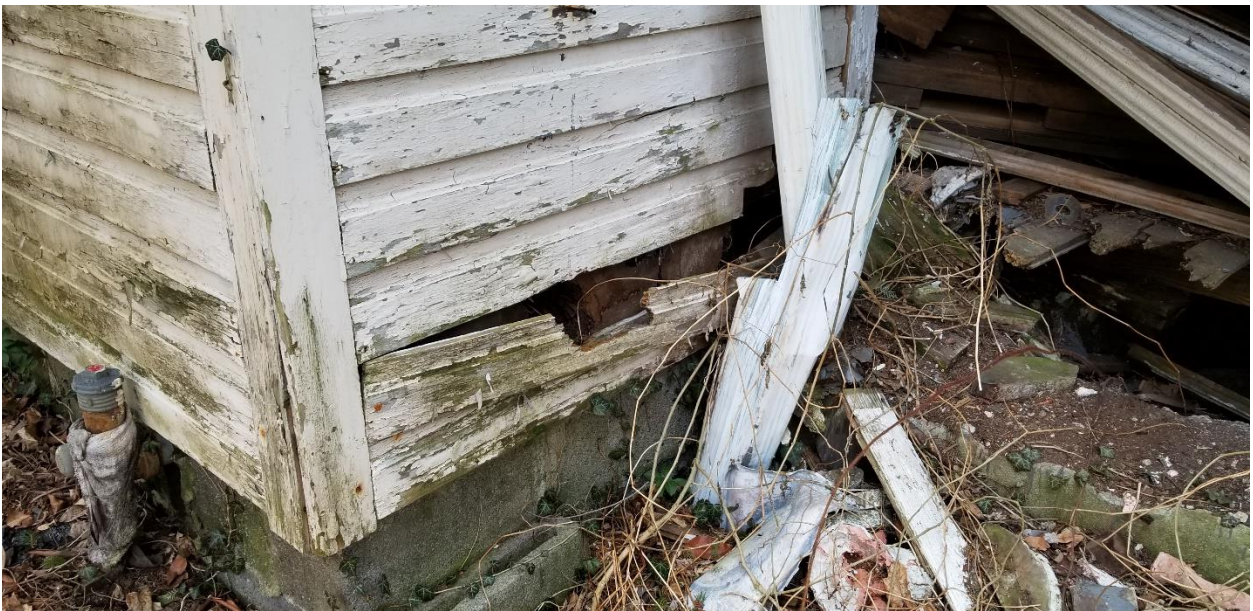
22. Deterioration of building addition area on southeast portion of structure

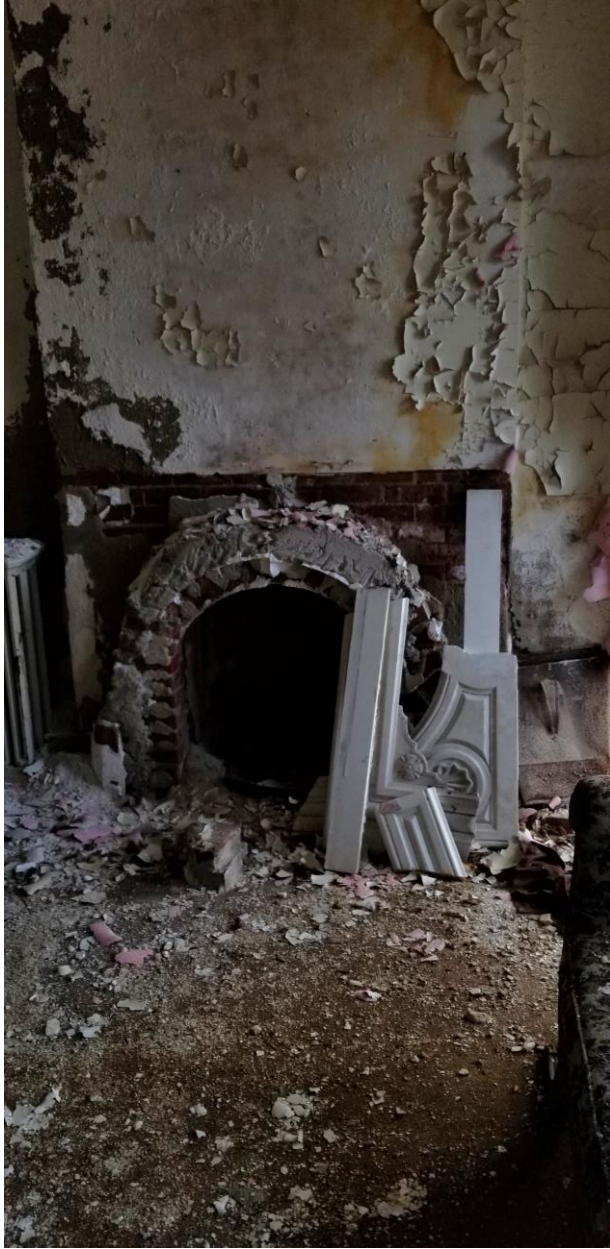
There is evidence of vandalism throughout the structure. Fireplace surrounds and mantles within the interior rooms have all been damaged or removed. Most all paint and finishes on ceilings and walls is peeling. Existing debris and materials are present throughout the building and would need to be removed.

23. Existing damaged fireplace mantle

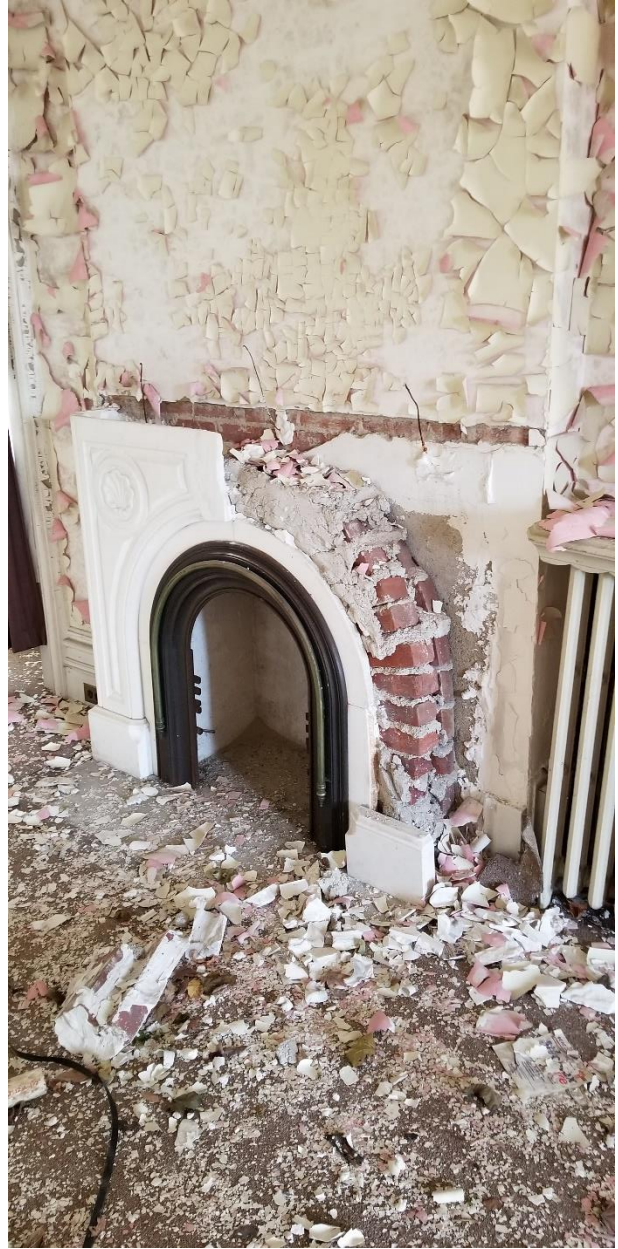
24. Existing damaged fireplace mantle

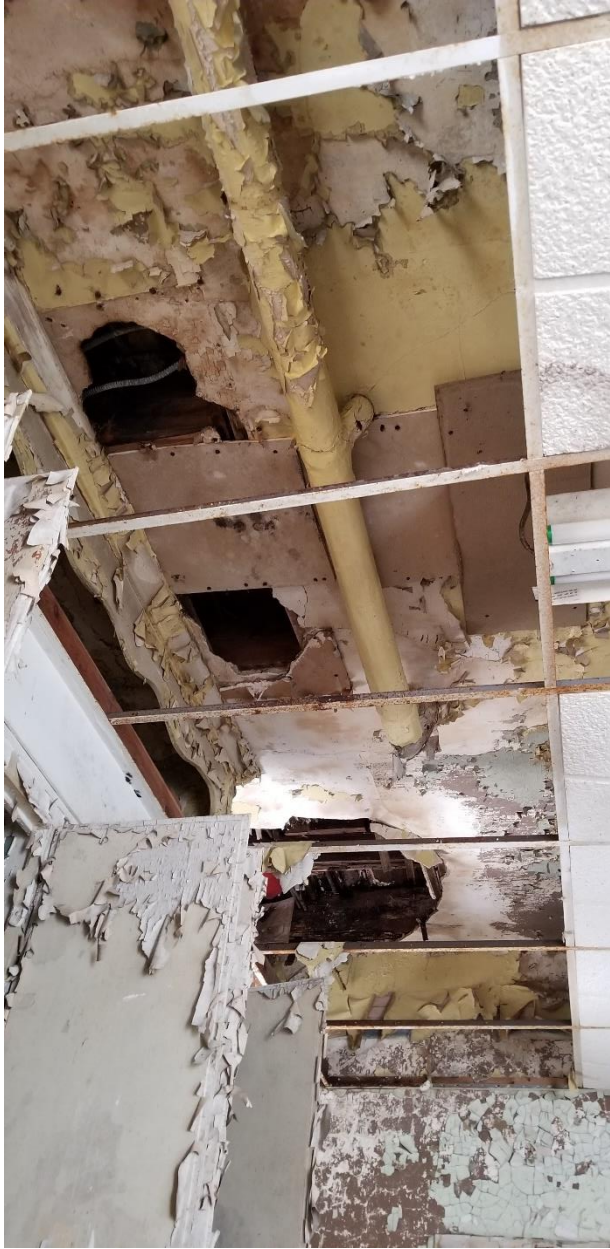
The existing roof is beyond its life expectancy and water infiltration is evident within the structure. There is evidence of damage to structural parts of the building. Areas of the interior ceiling and floor have been damaged due to water infiltration and leaks. On the exterior, existing gutters on the perimeter of the building have failed and would require replacement. All windows and exterior doors would require replacement in any restoration or rehabilitation of the structure. There is also mold throughout the structure.

27. Ceiling damage due to leaking roof above over kitchen area

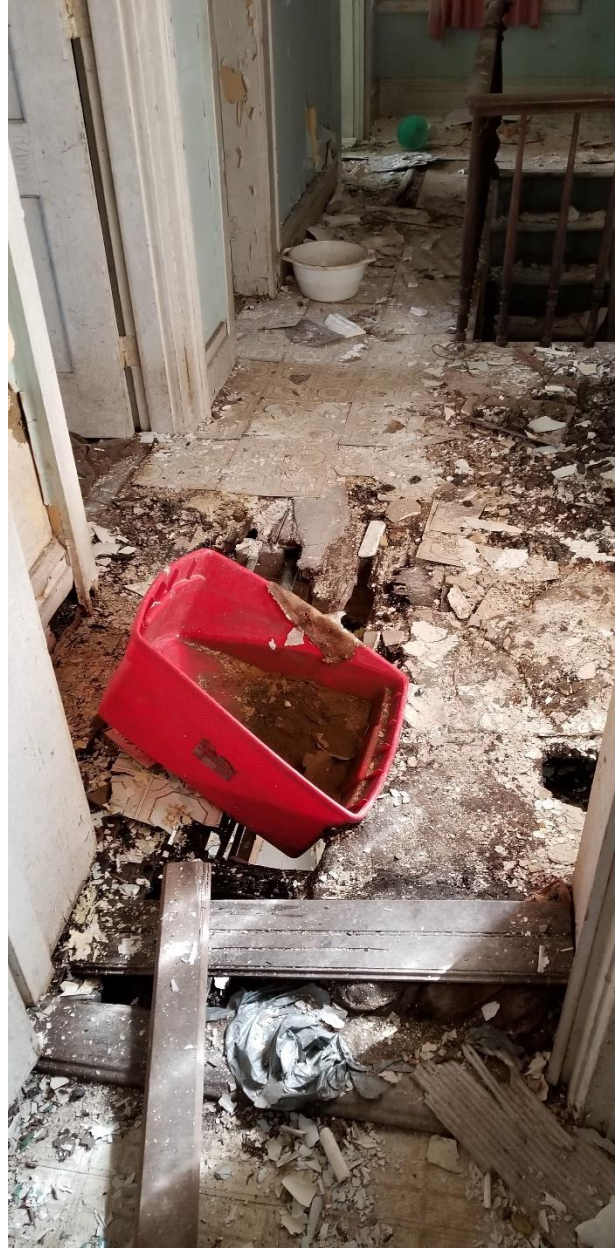
28. Missing floor over kitchen area, water collection from leaking roof, damage to structural components

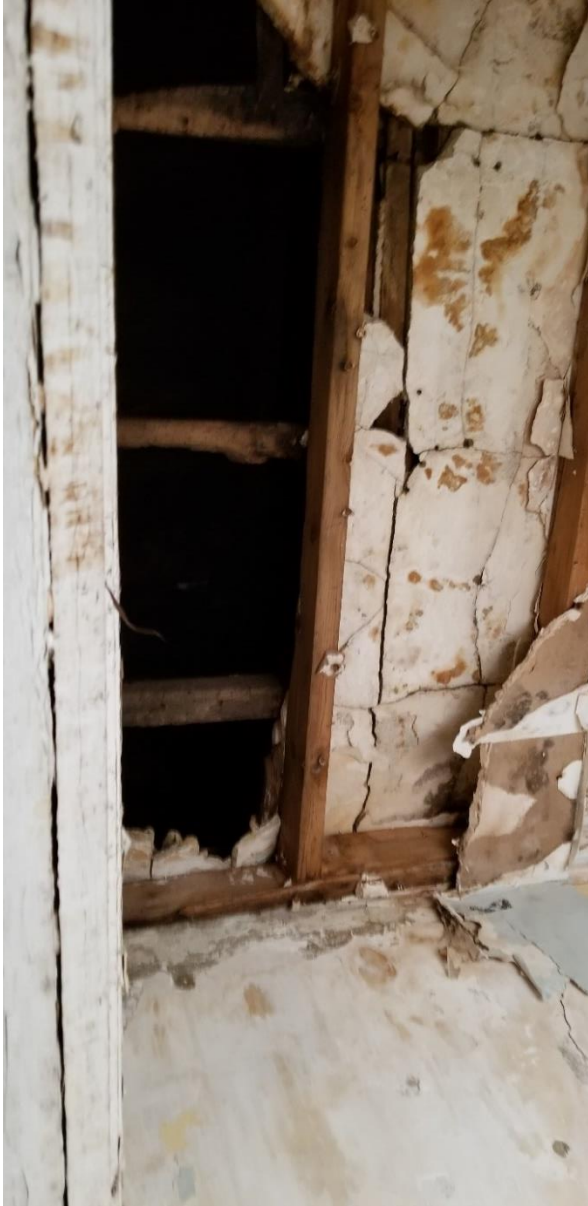
29. Ceiling damage due to leaking roof

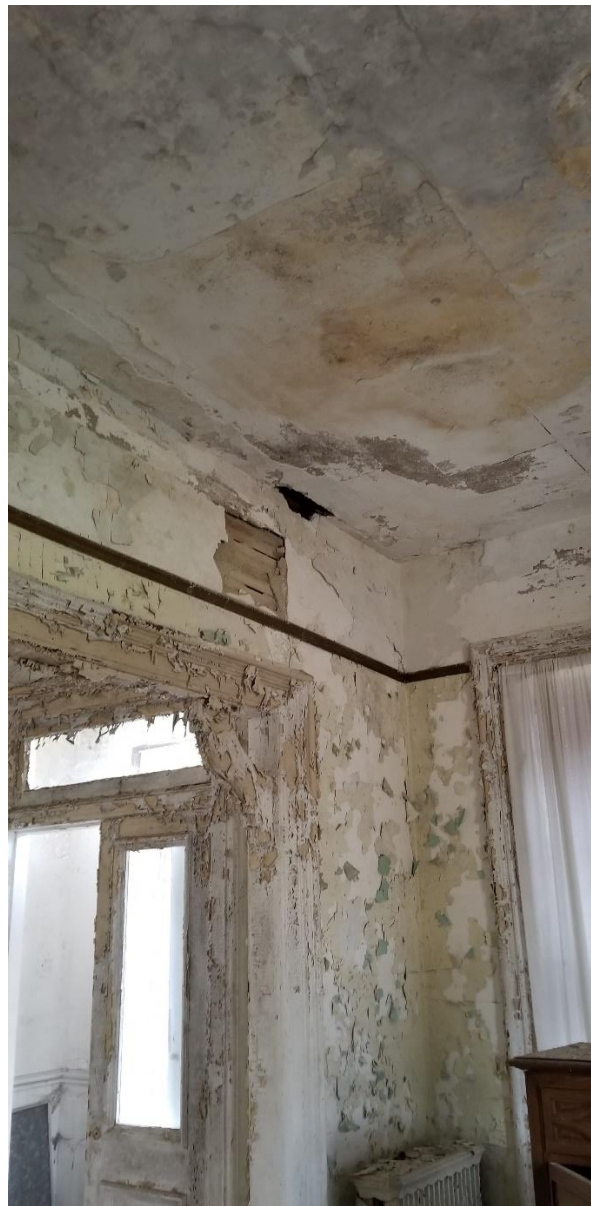
30. Staining on ceiling due to water Infiltration from roof leaks

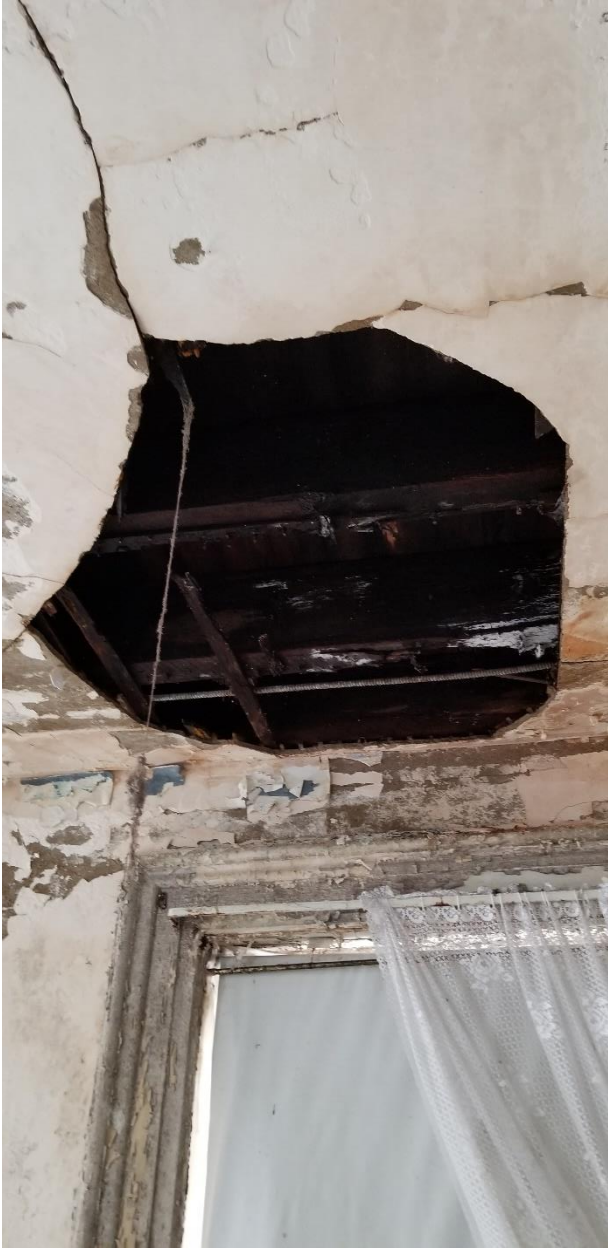
31. Ceiling damage due to leaking roof; areas of mold and mildew

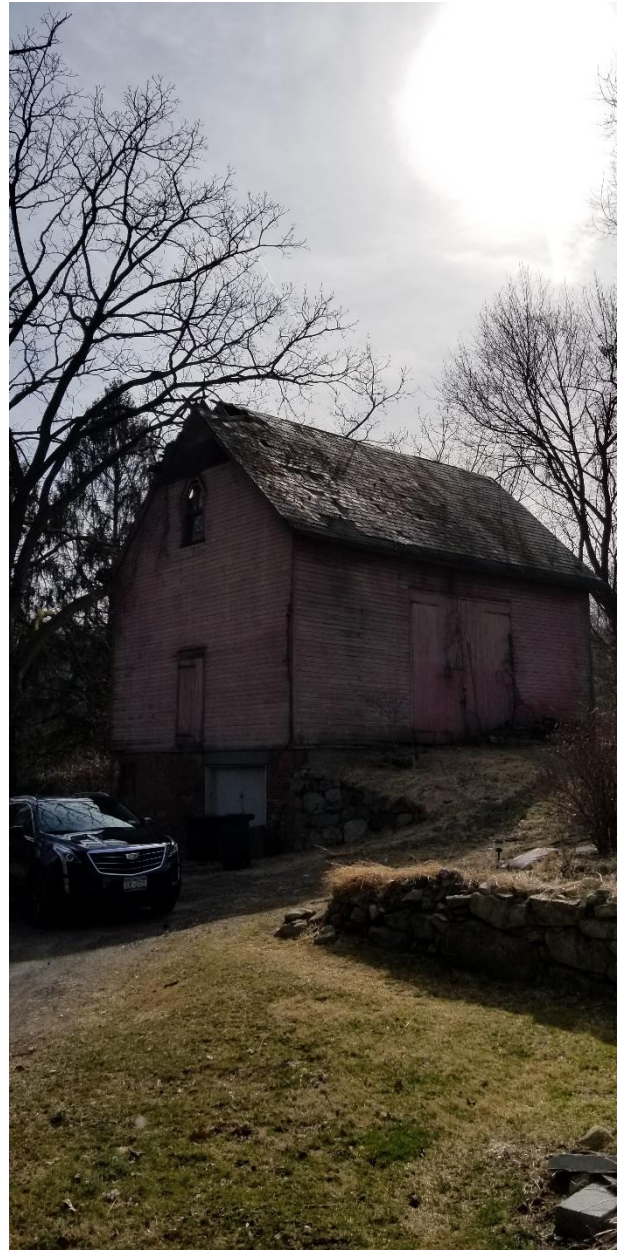
The roof is in a state of disrepair. Portions of the roof of the barn have collapsed or are missing in several sections, and the building is no longer weather tight. There is evidence of deterioration to the structural framing of the barn proximate to sections where the roof is missing. Portions of the floor have collapsed along the southern side of the building. Portions of the brick foundation have deteriorated. Due to the failures in the roofing and flooring, the structural integrity of the barn would have to be evaluated further.

33. Deterioration and damage to eastern end of roof

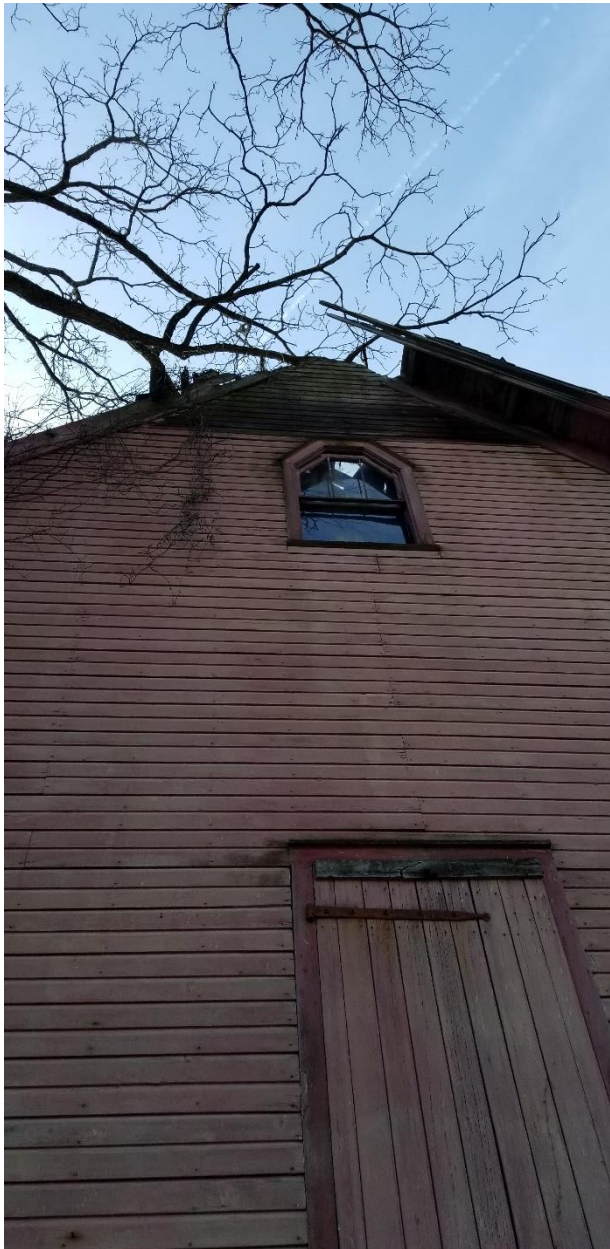
34. Deterioration and damage to eastern end of roof

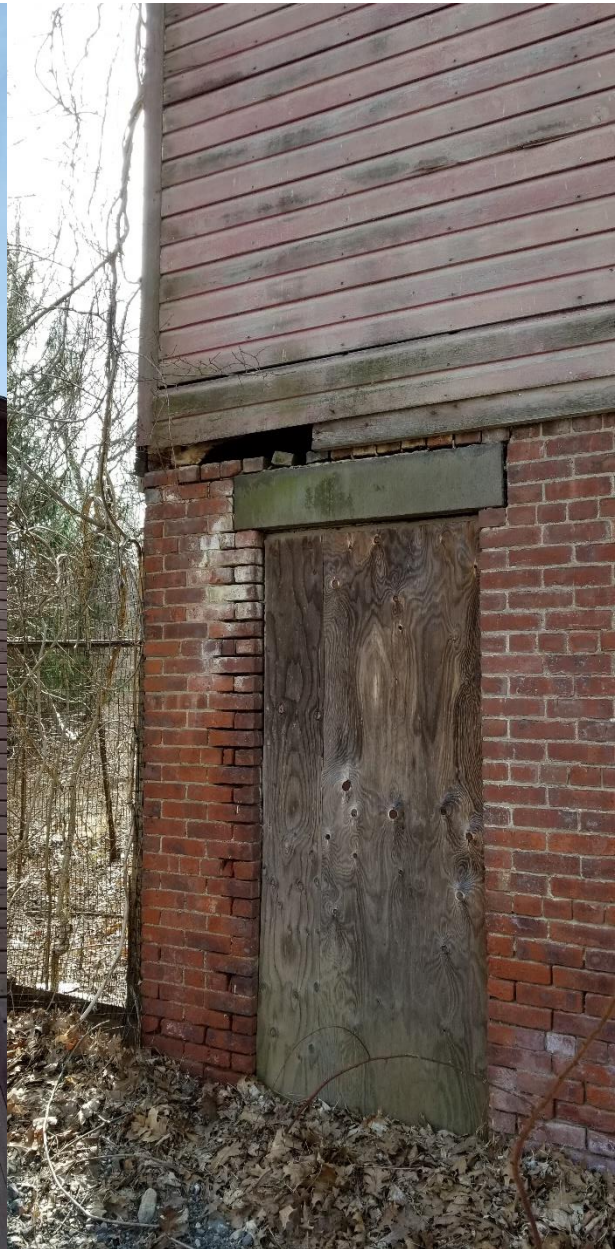
35. Deterioration to existing brick foundation

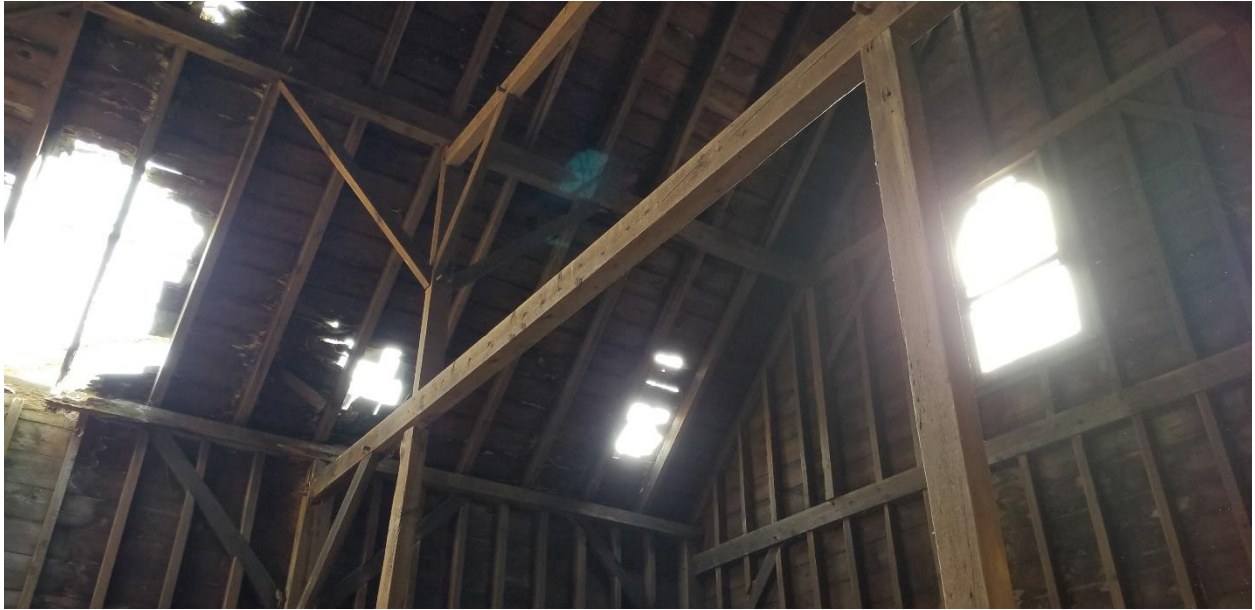
36. Damage and missing portions of existing roof

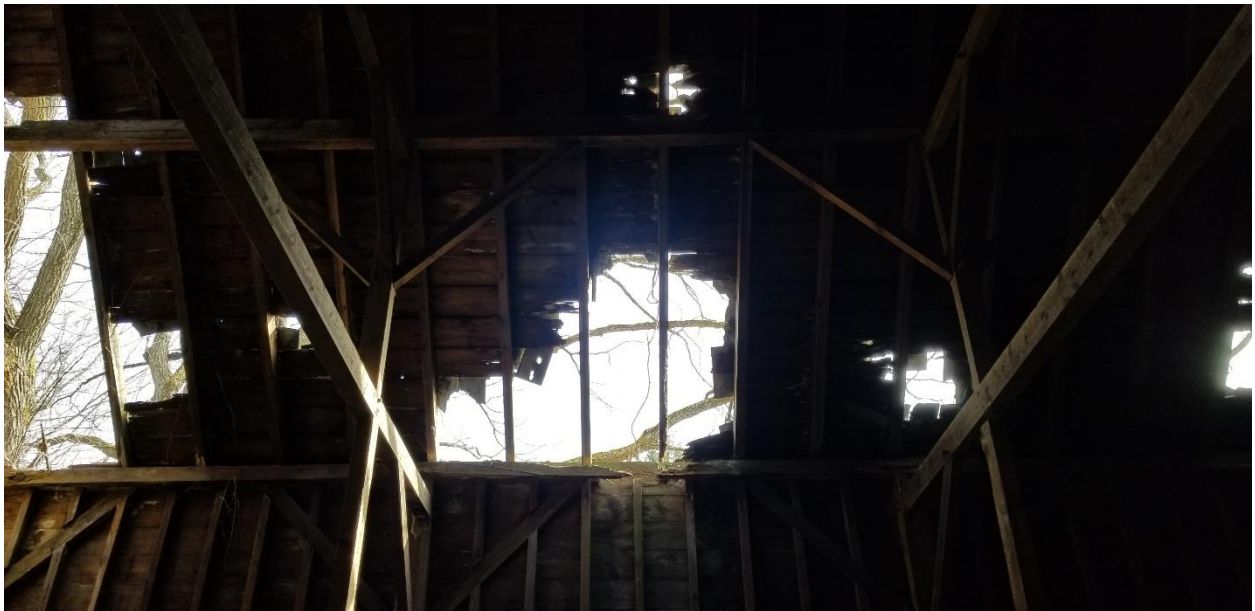
37. Damage and missing portions of existing roof

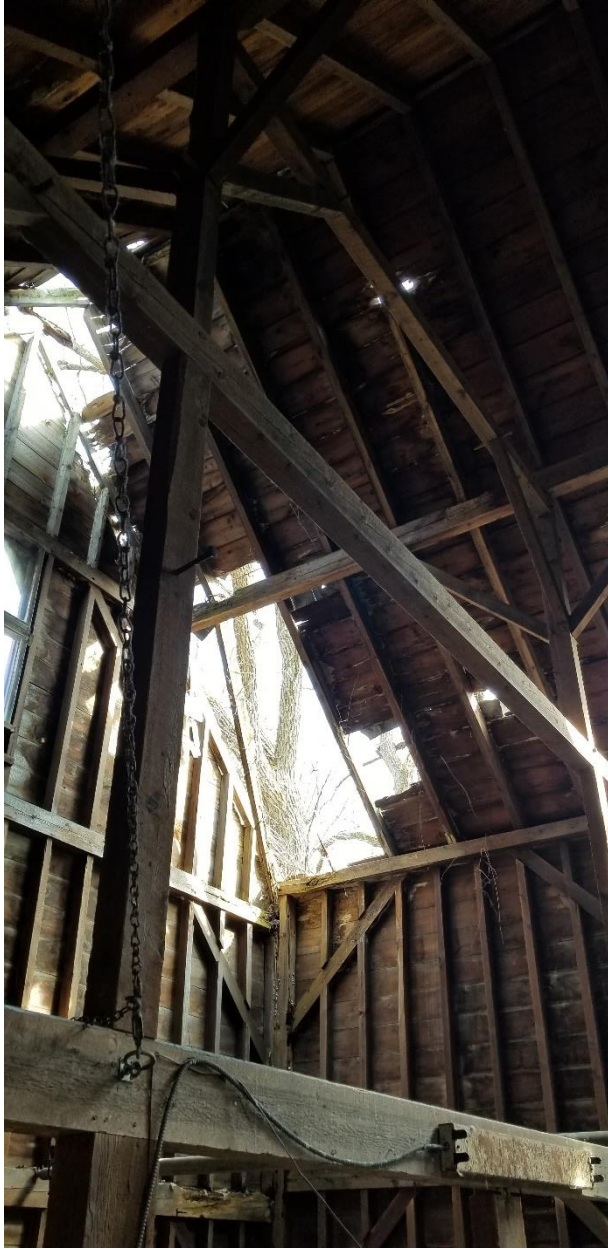
38. Deterioration and damage to roof and structural components

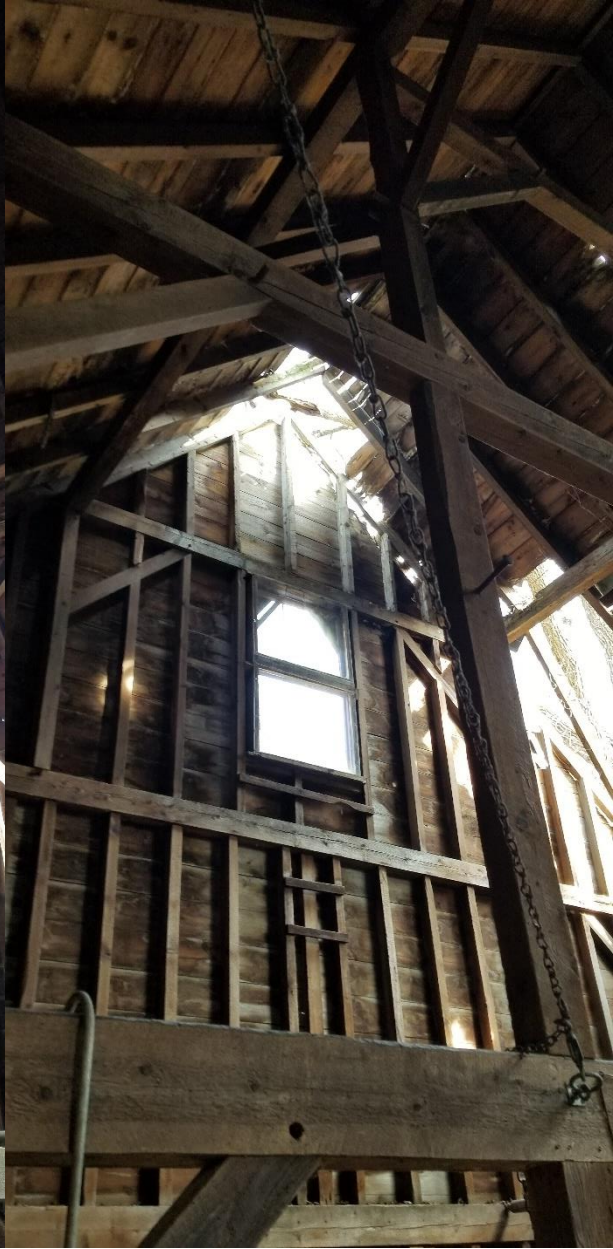
39. Missing sections of roof
