Re: DEC/SEQRA  
Cortlandt MOD/Evergreen Manor Development  
2003 Crompond Road, Cortlandt, Westchester County  
18PR08018

Evergreen Manor Project  
Alternative Analysis

Re: Evergreen Manor Project Specifically Former Evergreen Manor Hotel

## **Former Evergreen Manor Hotel (Photos 1- 31)**

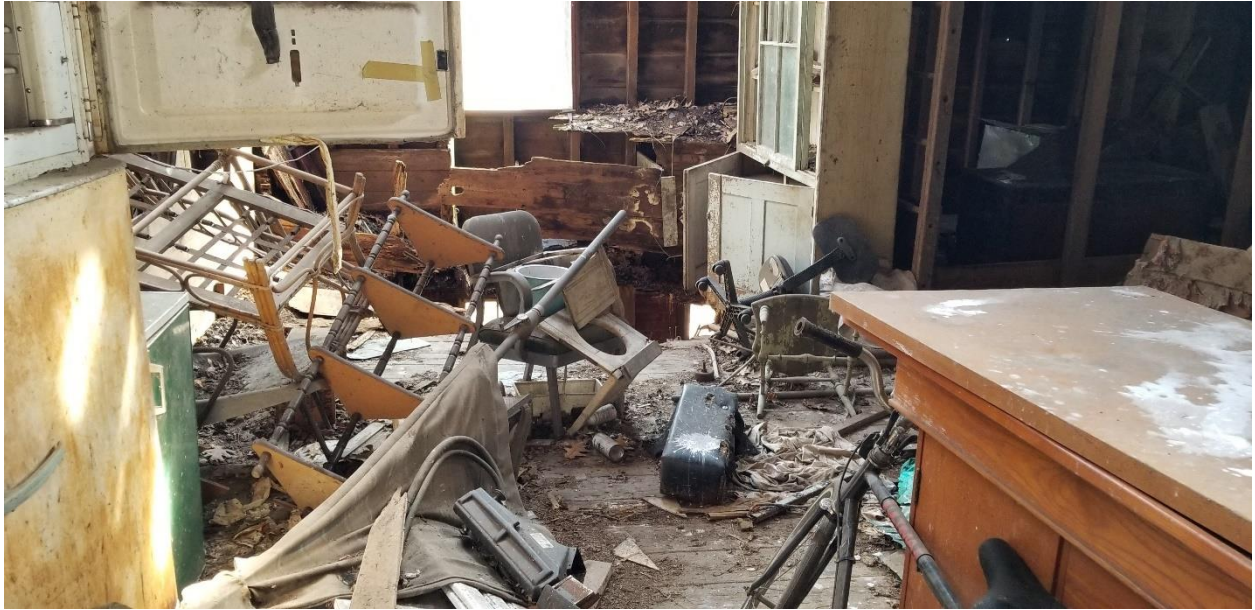
40. Collapsed floor on southern portion of barn

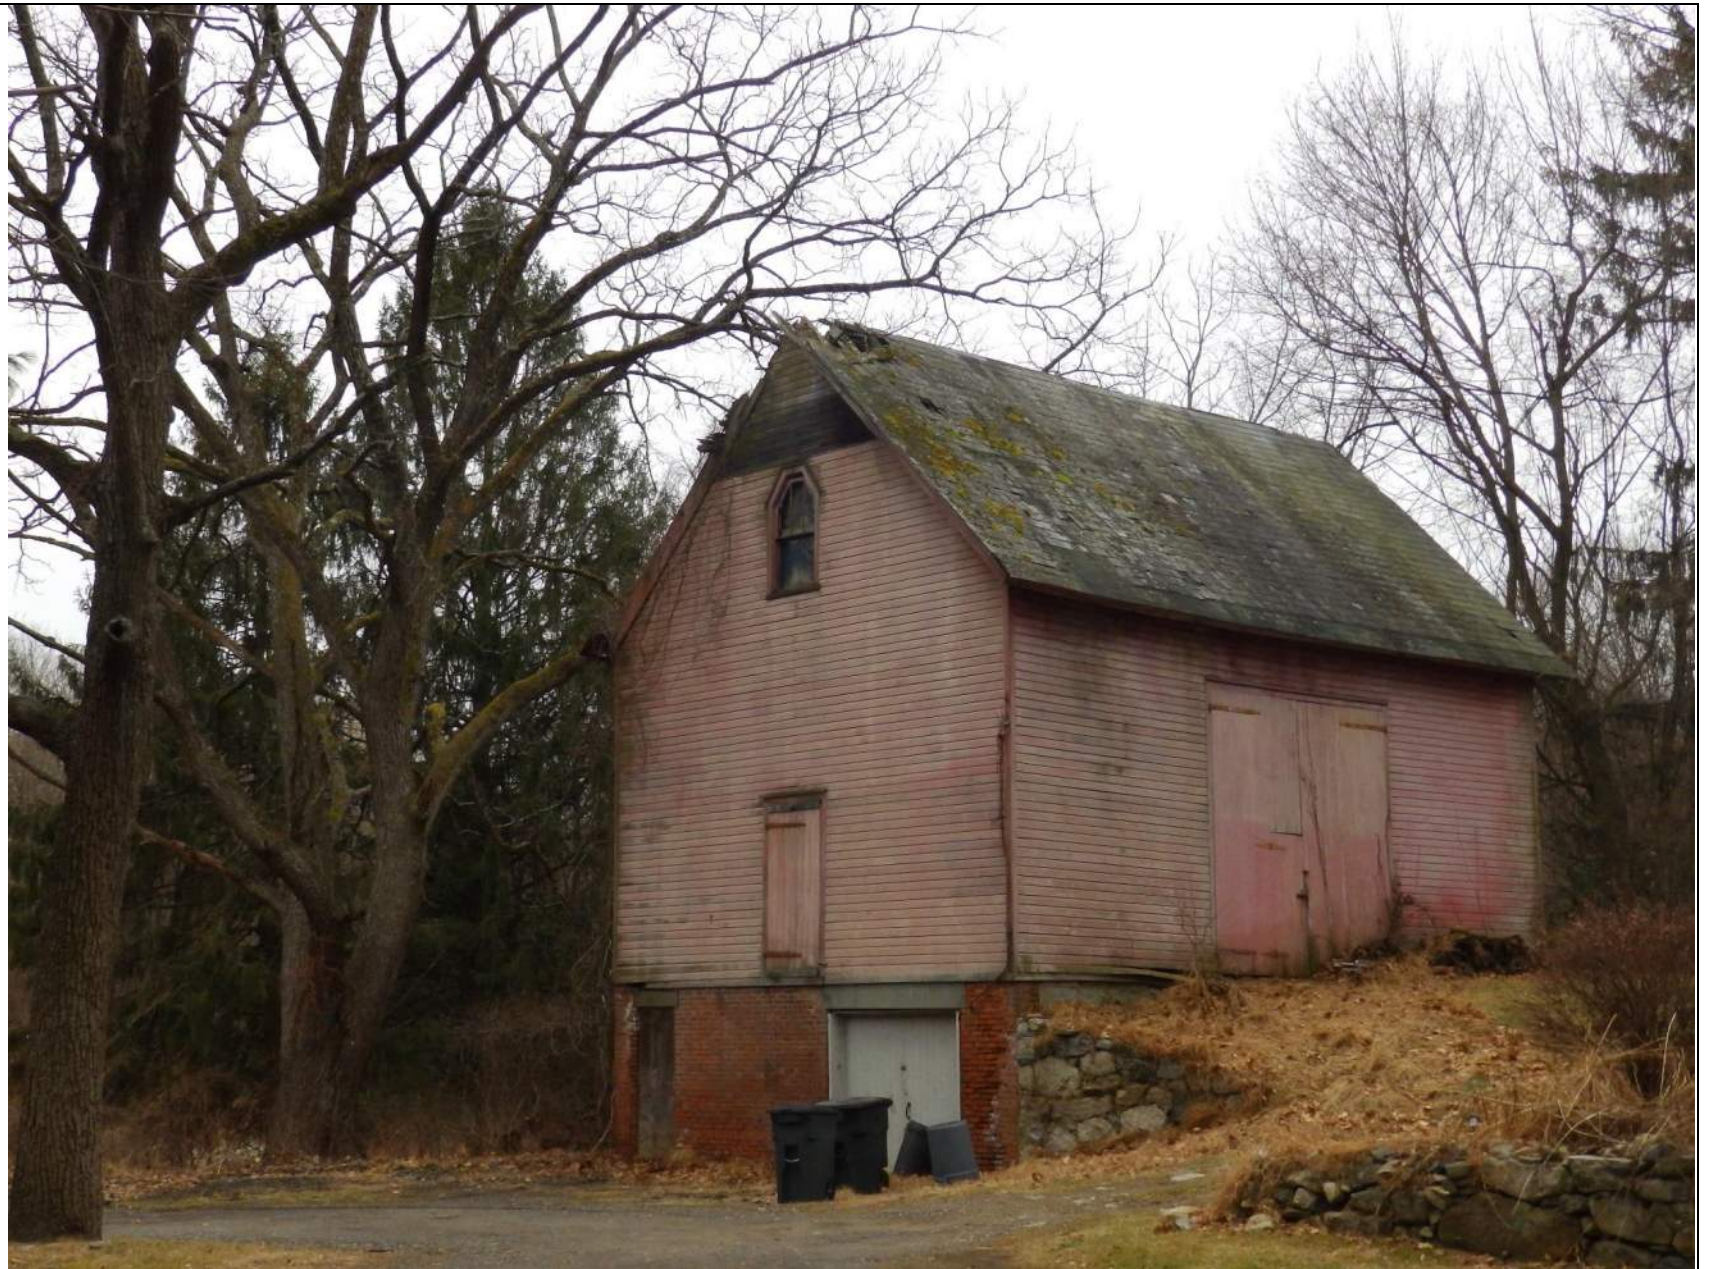
17. Western elevation of the Barn. Pool house addition has detached and collapsed.
