# Town of Cortlandt Quarry Site Improvements Project

Cortlandt Quarry Committee Meeting | 10 October 2023

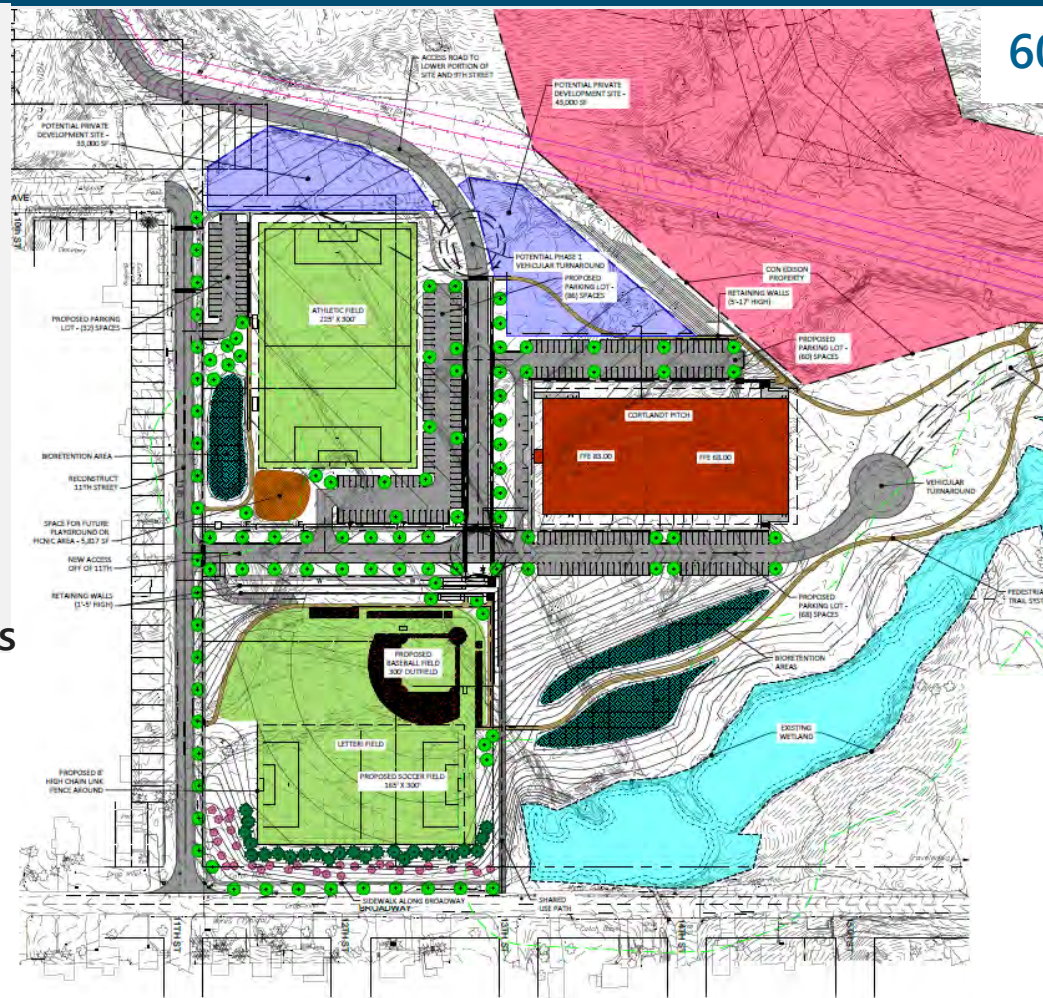
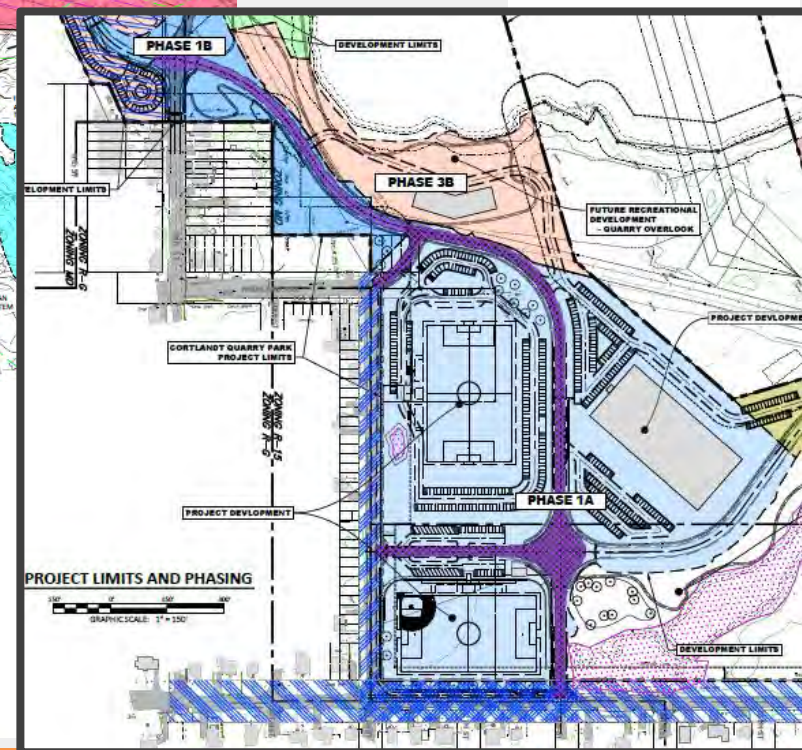
## Design Development

- Upper portion of site only
- Design allows for all future phases
- Cortlandt Pitch
- Potential development sites
- 11<sup>th</sup> Street improvements
- Site access
- Athletic fields
- Stormwater
- Pedestrian and vehicular access

- CON EDISON PROPERTY
- HOLTEC PROPERTY
- DELINEATED WETLAND
- PROPOSED ATHLETIC FIELDS
- PROPOSED CORTLANDT PITCH BUILDING
- PROPOSED ROADWAYS AND PARKING LOTS
- PROPOSED STORMWATER MANAGEMENT AREA
- POTENTIAL PRIVATE DEVELOPMENT SITE

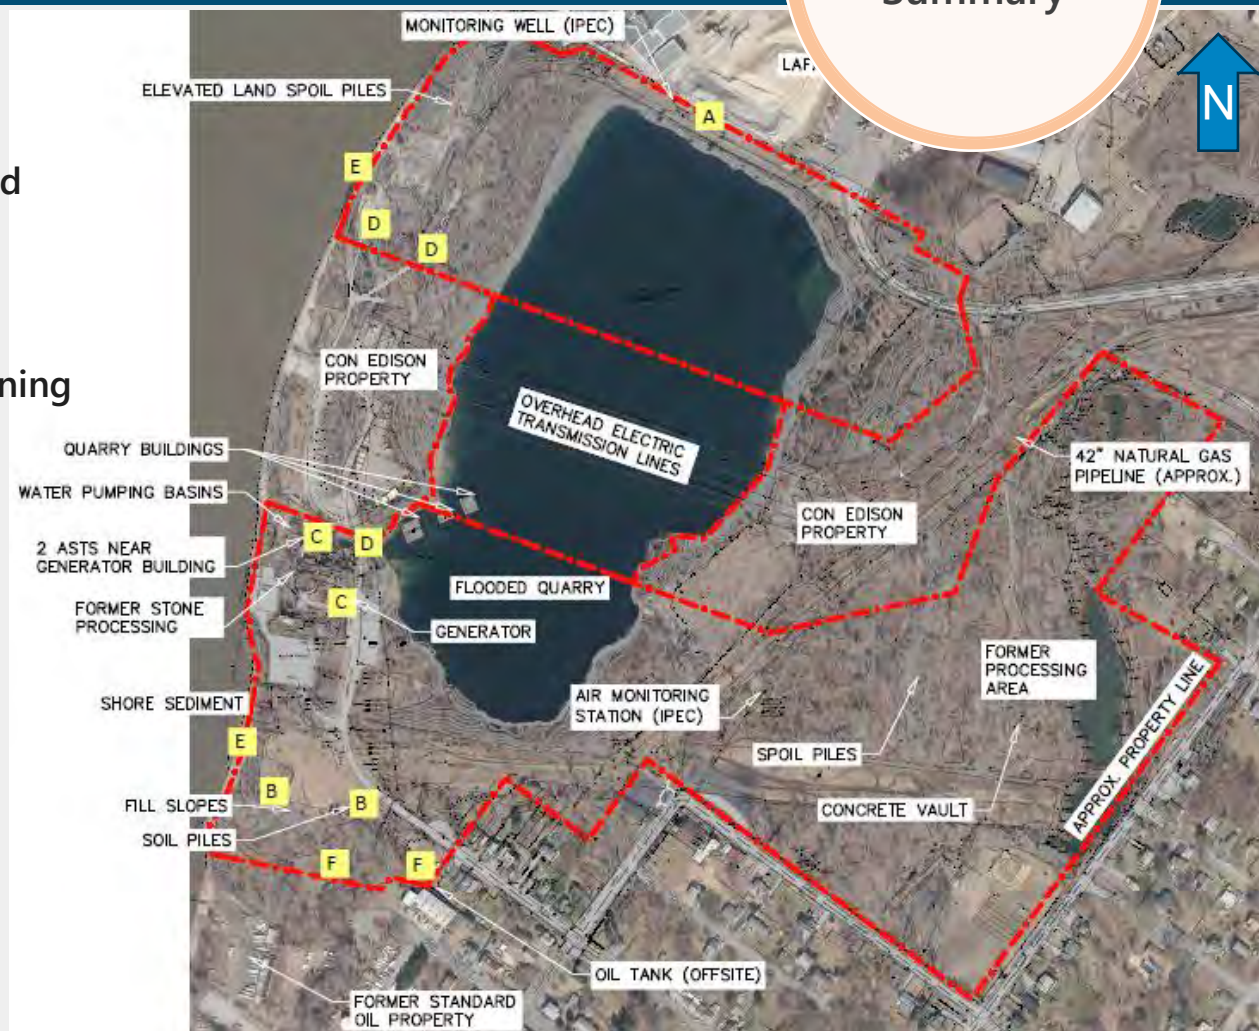
### Phase I ESA Summary

Six (6) Recognized Environmental Conditions (RECs) Were Identified During Phase 1 Study:

- A) Previously Reported Petroleum Spills at LaFarge
- B) Debris & Urban Fill (Cinders, Metal, Glass, etc.)
- C) Diesel Generators, Petroleum Storage Tanks, Surface Staining
- D) Former Chemical Storage Areas
- E) Hudson River Shoreline (PCBs)
- F) Previously Reported Spills at the Former Standard Oil Petroleum Bulk Storage (PBS) Facility

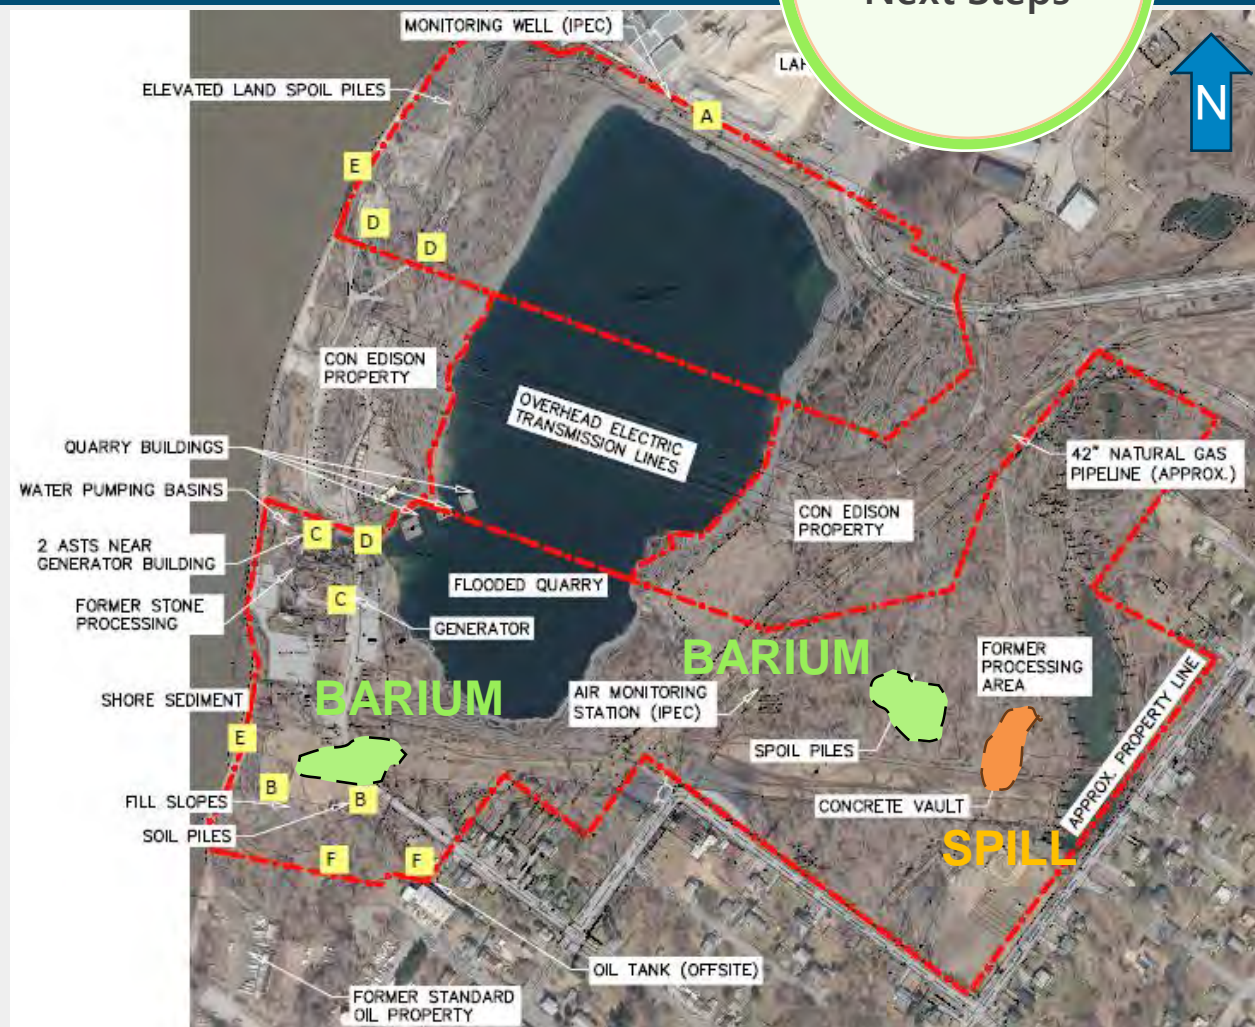
## Phase II ESA Findings

- A. PFOA/PFOS detected in Groundwater below NYSDEC Draft WQGVs for recreational use.
- B. Barium detected above restricted residential use soil cleanup objectives (RRUSCOs).
- C. No obvious indications of petroleum impacts.
- D. Pesticides detected above unrestricted use soil cleanup objectives (UUSCOs).
- E. No obvious indications of PCB impacts to Hudson River shoreline sediment.
- F. Low concentrations of petroleum-derived compounds detected in surface soil.

## Other Identified Issues:

- Petroleum Spill: Heavy staining/odors detected in former processing area. NYSDEC Spill Department Was Notified.
- Radiological: No obvious indication of radiological impacts.
- Gypsum Dust: Not evident after visual inspection.

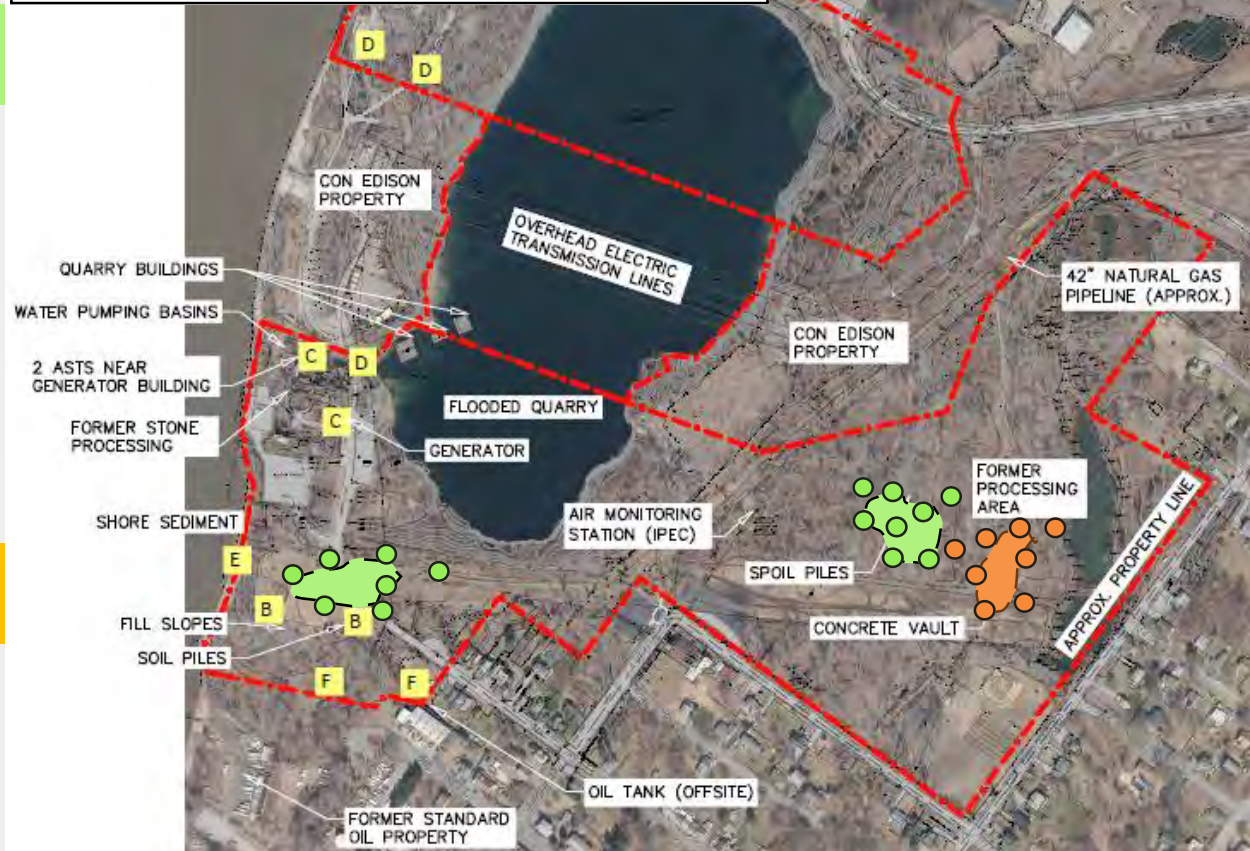
## Proposed Surface Soil Samples Proposed Soil Borings

## Phase II ESA Recommendations

- A. No further action recommended adjacent to LaFarge parcel.
- B. Collection of additional samples to estimate potential horizontal and vertical extent of noted barium detections.
- C. No further action is recommended. Wastes generated during eventual removal of ASTs/Generators will need to be managed appropriately.
- D. No further action is recommended adjacent to former Con-Edison parcel.
- E. No further action recommended at Hudson River & Quarry Pond Shoreline.
- F. Soil to be managed by an environmental professional, should development occur in this area.

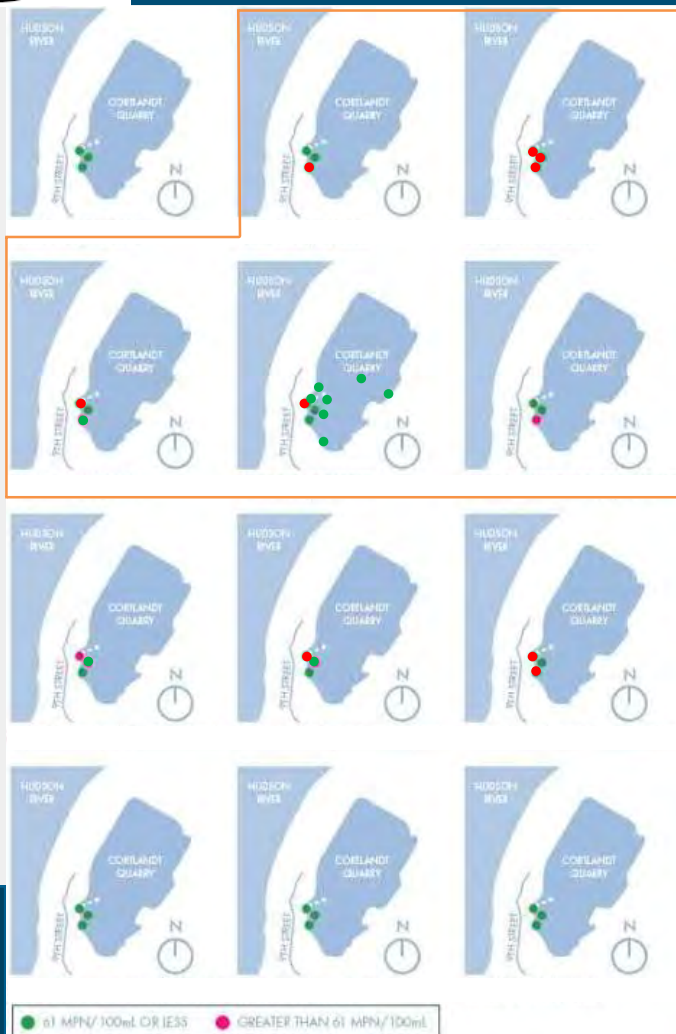
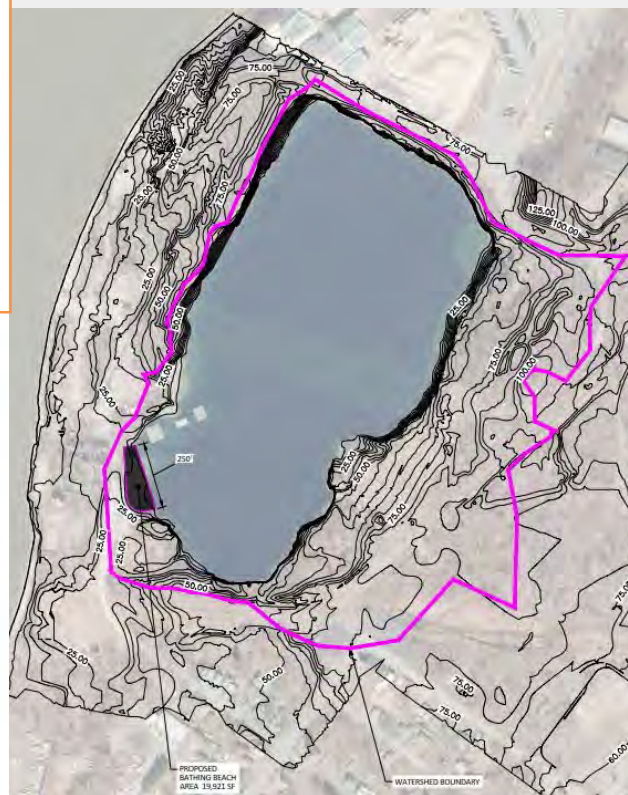
## 2023 Sampling

- Sampled 06/22/2023-08/10/2023
- Much more rain in 2023 compared to 2022 – more enterococcus violations
- Other parameters relatively consistent with previous data
- Enterococcus speciation sampling revealed bacteria species present both naturally and in fecal samples
- No sewer, no septic within watershed
- Shallow groundwater flow likely directed away from quarry
- Ultimately WCDOH decision beyond 2024 sampling

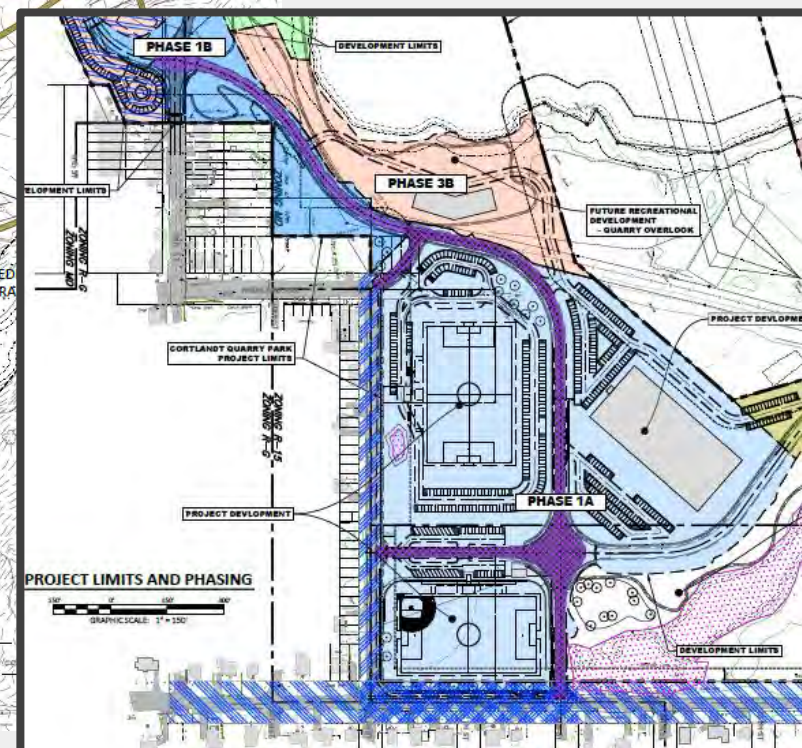
30% Design

## Design Development

- Upper portion of site only
- Design allows for all future phases
- Cortlandt Pitch
- Potential development sites
- 11<sup>th</sup> Street improvements
- Site access
- Athletic fields
- Stormwater
- Pedestrian and vehicular access

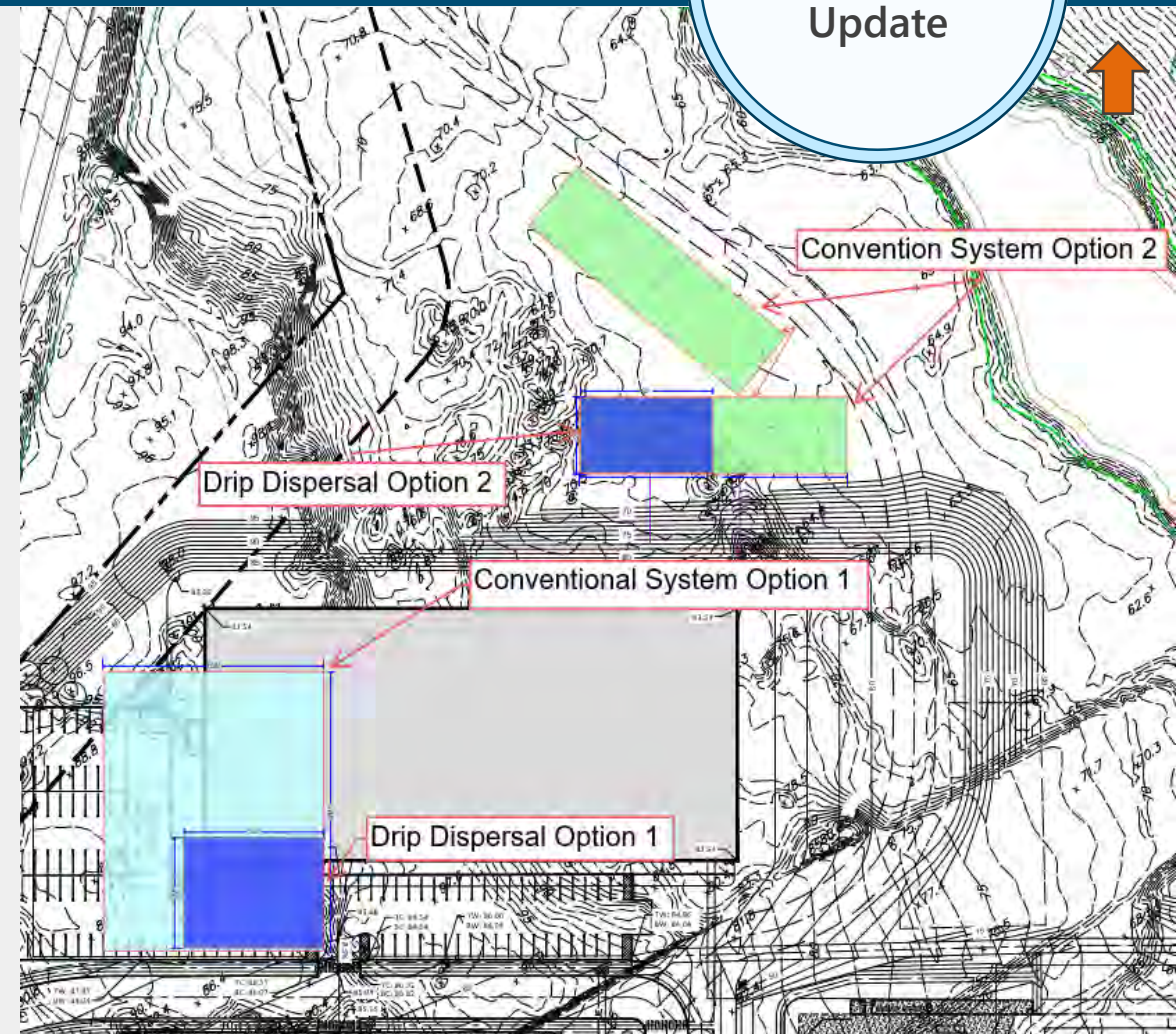
## Cortlandt Pitch Septic Design

- Potentially two options for conventional septic drainfield – large footprint required
- Drip dispersal a potential option
  - Significantly smaller footprint allows for more parking, however pretreatment needed – additional cost
- Final grading layout and percolation tests needed for final wastewater treatment design
