Re: DEC/SEQRA  
Cortlandt MOD/Evergreen Manor Development  
2003 Crompond Road, Cortlandt, Westchester County  
18PR08018

Evergreen Manor Project  
Alternative Analysis

Re: Evergreen Manor Project Specifically Former Evergreen Manor Hotel

## **Former Evergreen Manor Hotel (Photos 1- 31)**

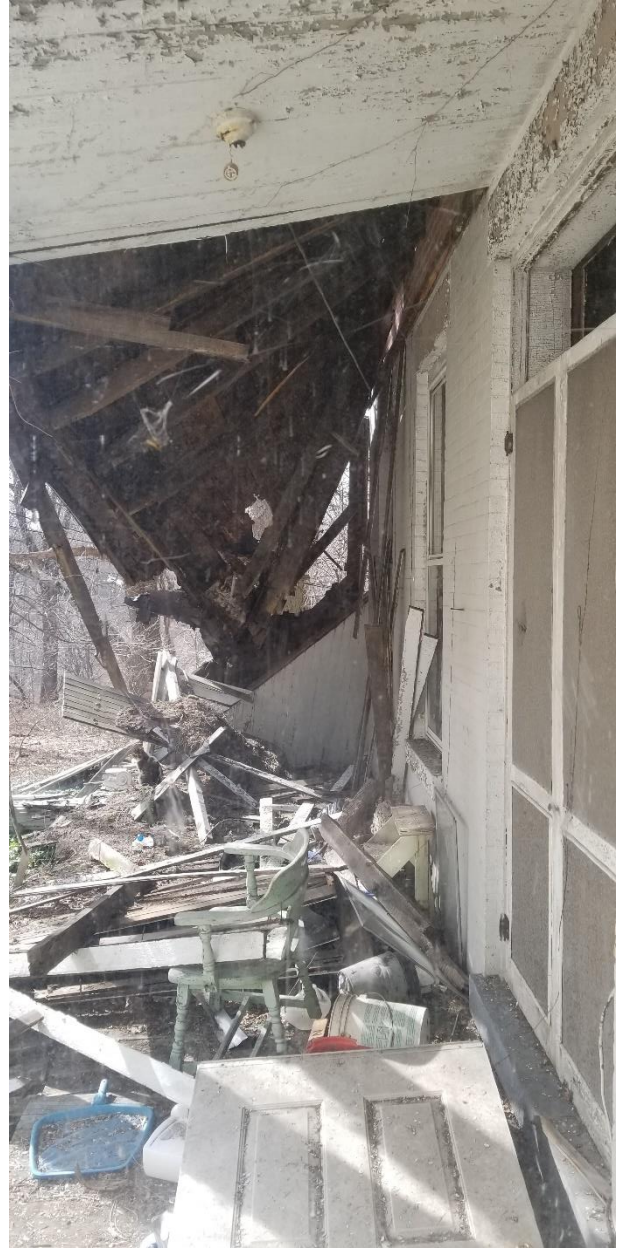
The wooden covered porches located on the western, southern and eastern sides of the building have failed and collapsed. The columns on the northern side of the building have apparent rot. These elements would require removal and replacement. Roofing systems over the main portico along the front (north) elevation would also need to be removed and replaced. Decorative elements at the front entry of the structure have been removed. Portions of the floor at the entry vestibule have collapsed.

15. Collapsed porch roof on south elevation with debris

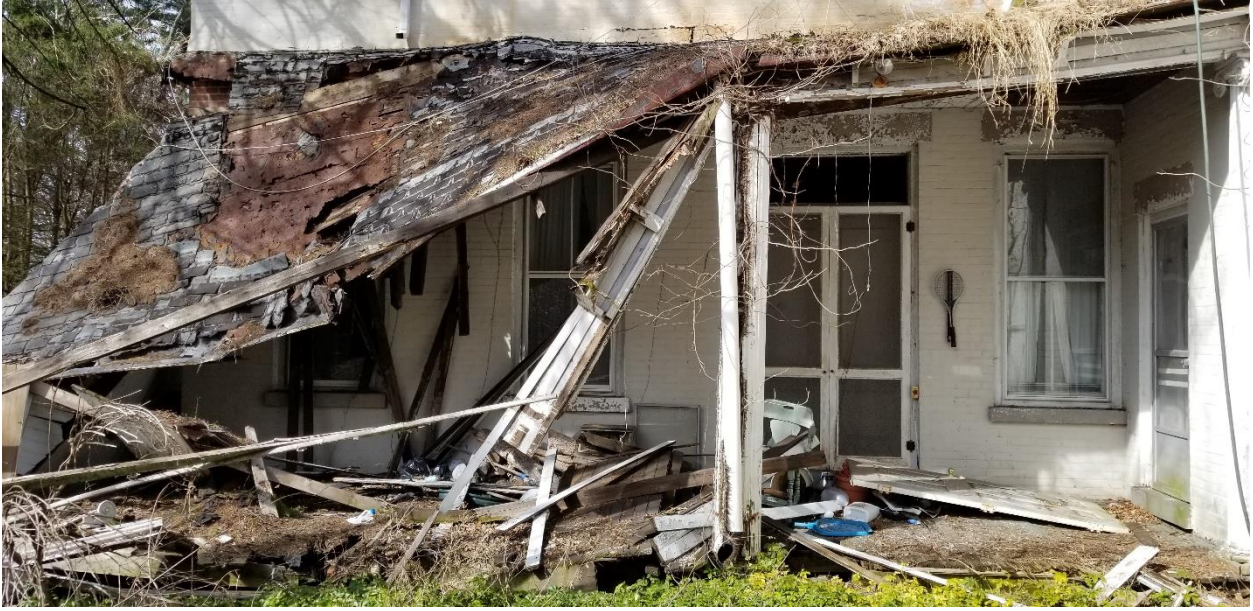
16. Collapsed porch roof on south elevation with debris

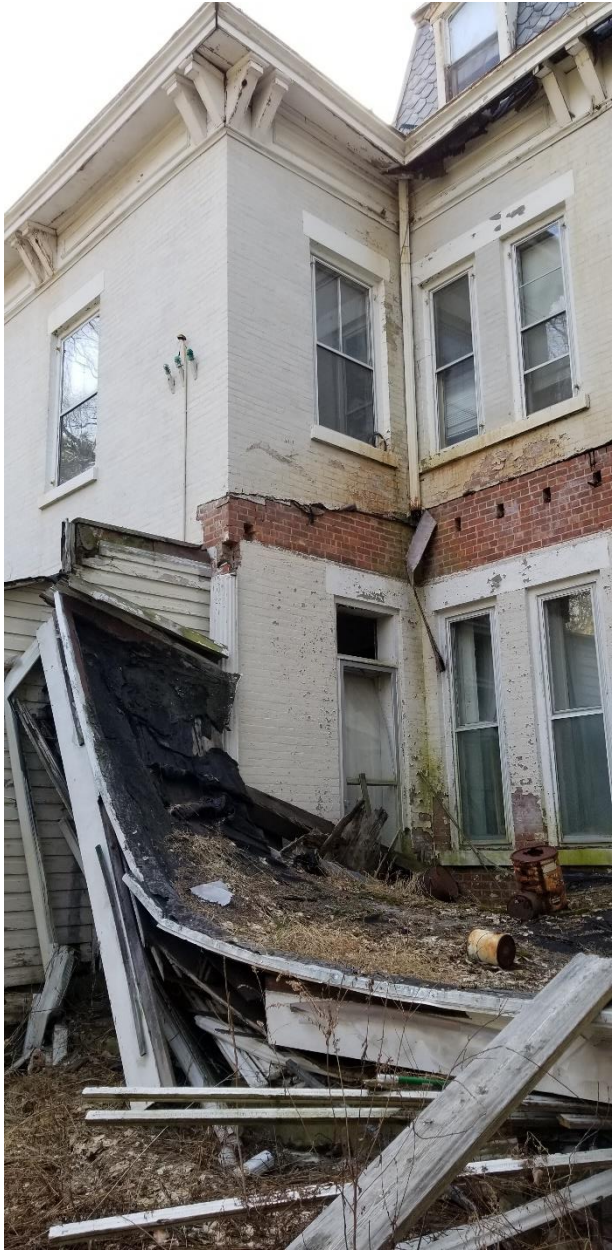
17. Collapsed porch roof on east elevation with debris

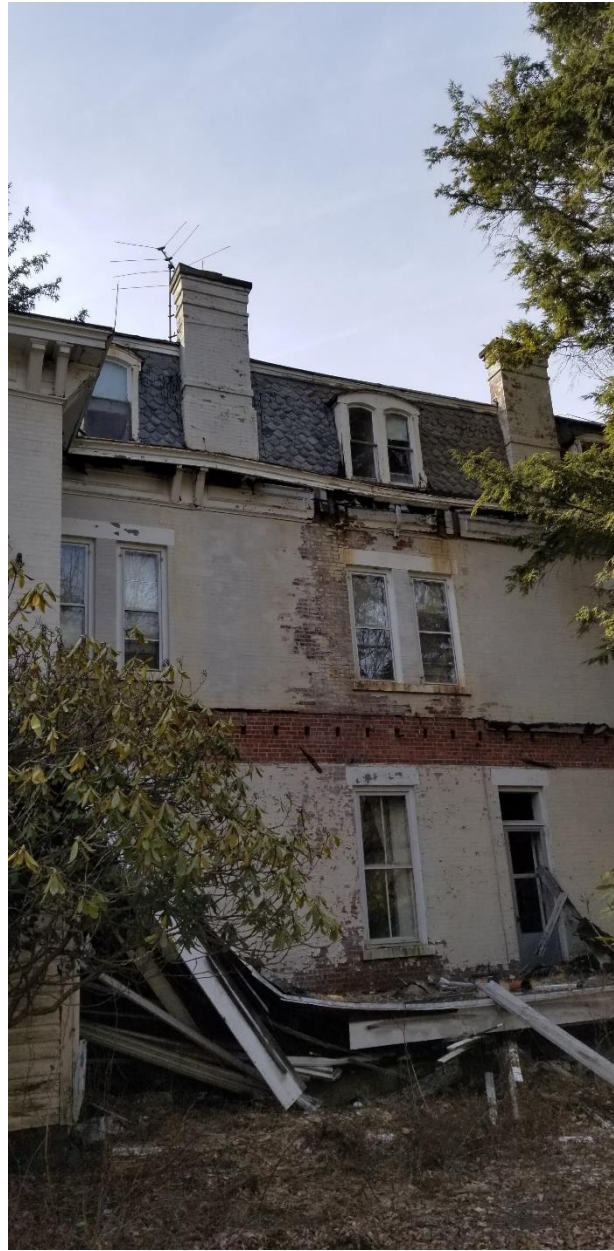
18. Collapsed porch roof on south elevation; debris

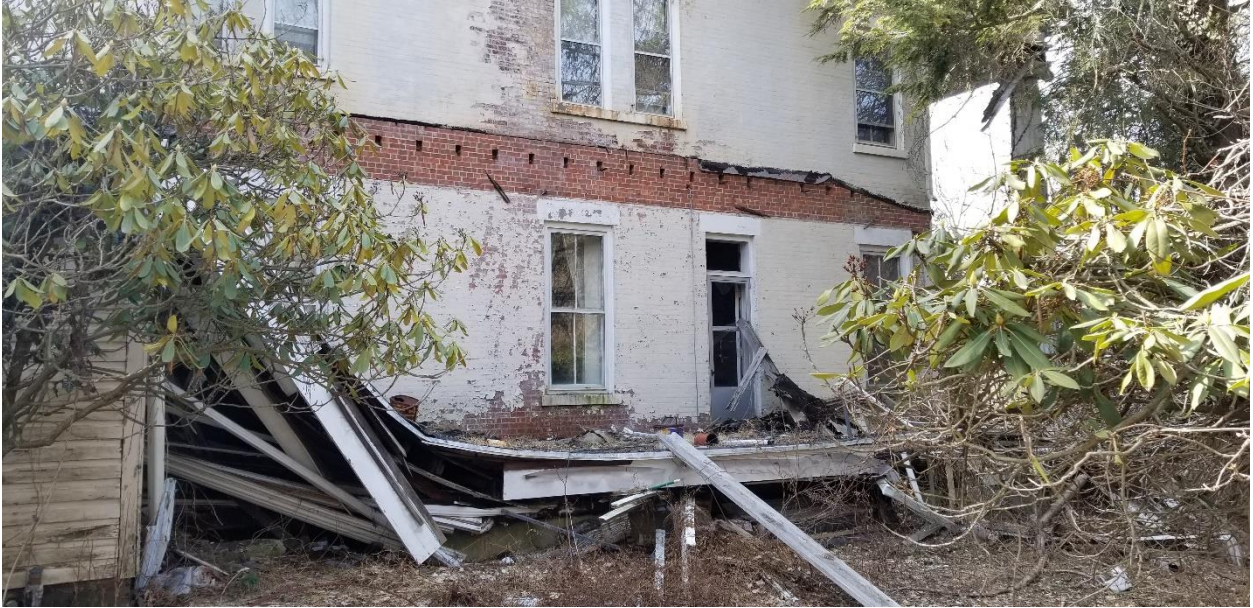
19. Collapsed porch roof on south elevation with debris

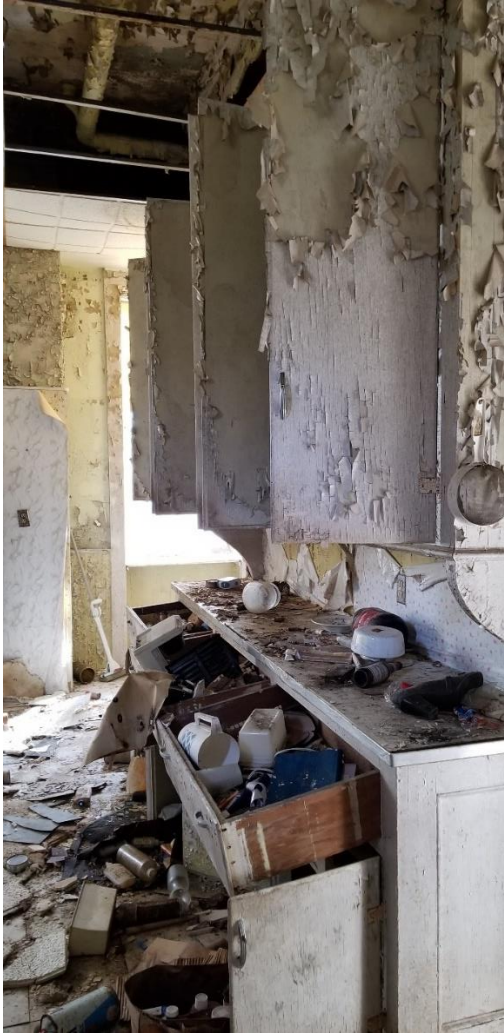
25. Kitchen – renovated after construction of structure

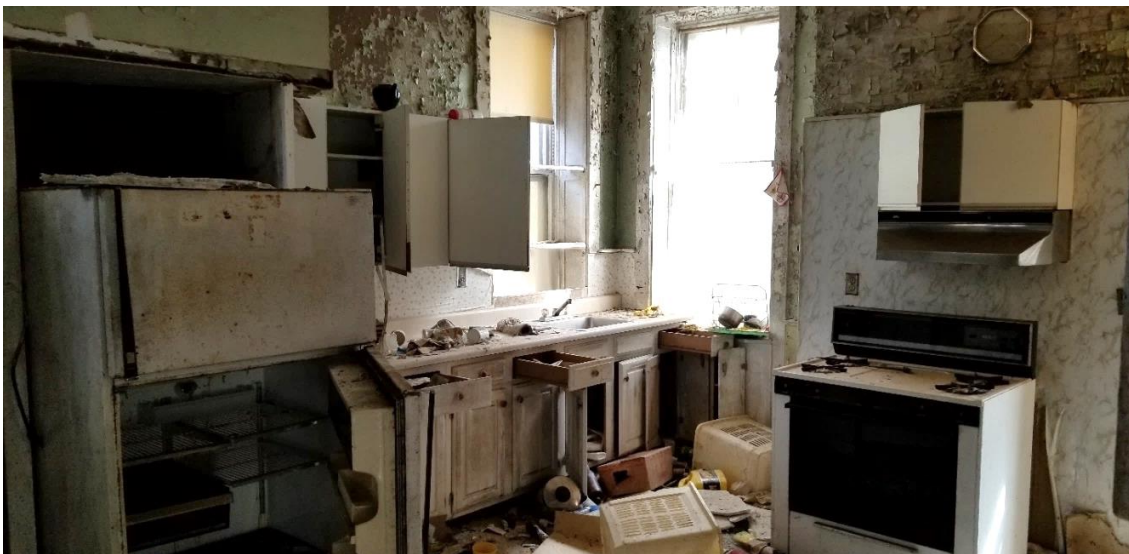
26. Kitchen – renovated after construction of structure

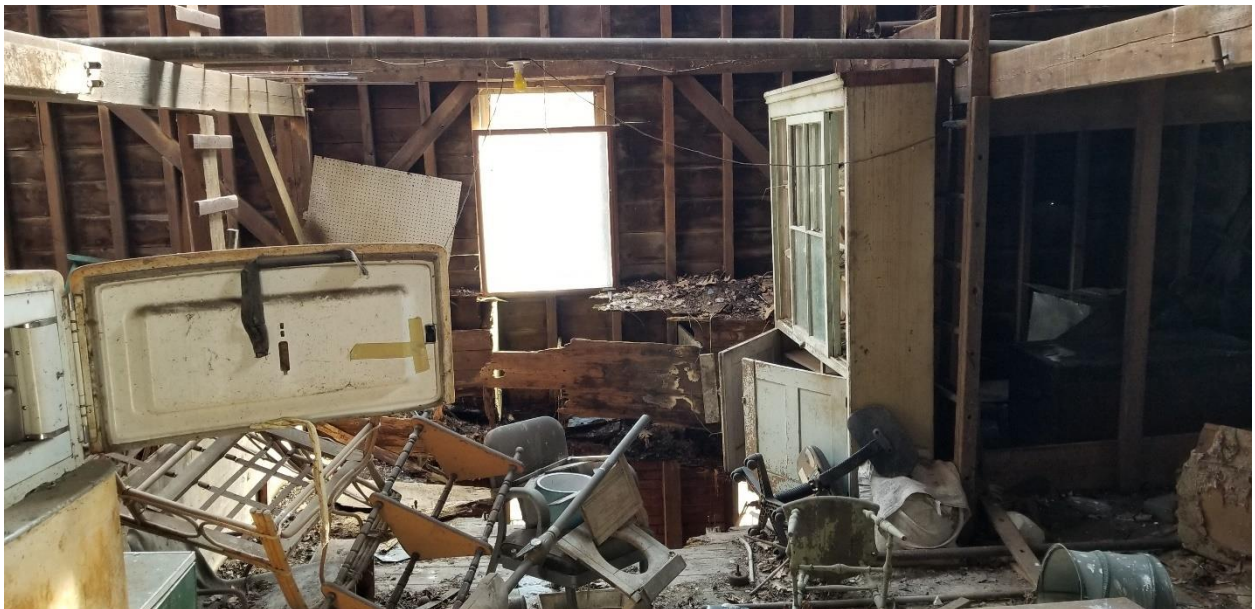
The roof is in a state of disrepair. Portions of the roof of the barn have collapsed or are missing in several sections, and the building is no longer weather tight. There is evidence of deterioration to the structural framing of the barn proximate to sections where the roof is missing. Portions of the floor have collapsed along the southern side of the building. Portions of the brick foundation have deteriorated. Due to the failures in the roofing and flooring, the structural integrity of the barn would have to be evaluated further.

41. Collapsed floor on southern portion of barn

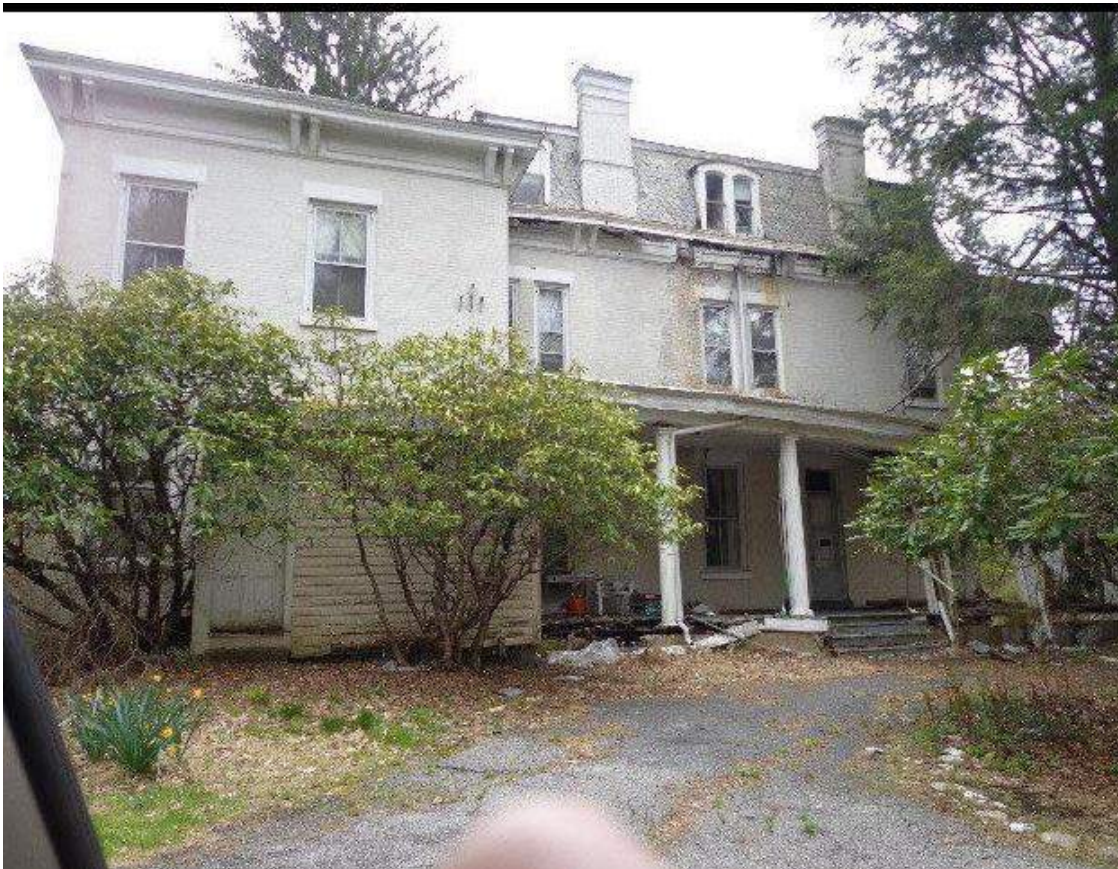
Figure 4: Photo of the Manor, taken in 2017 by Norma Barrett, courtesy of Abandoned Peekskill NY. <sup>11</sup>

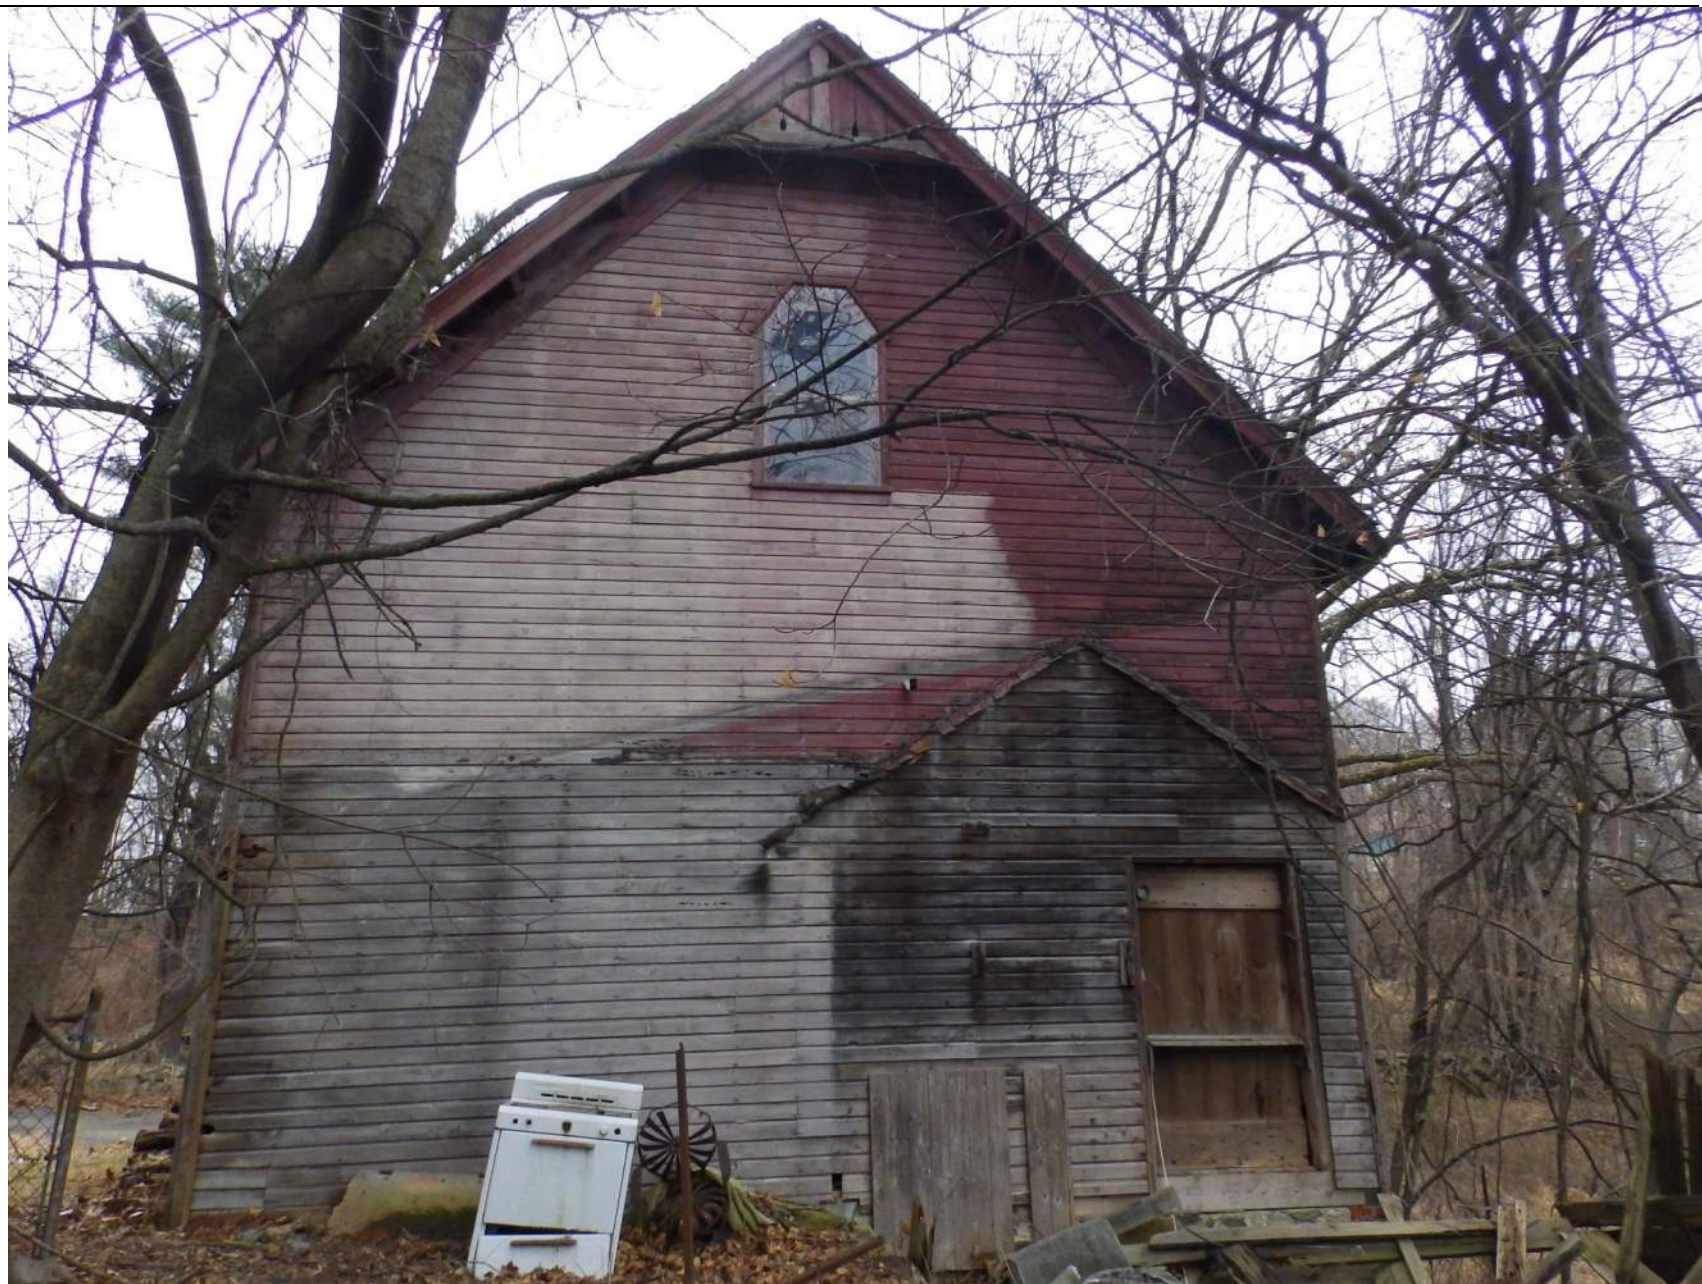
17. Western elevation of the Barn. Pool house addition has detached and collapsed.

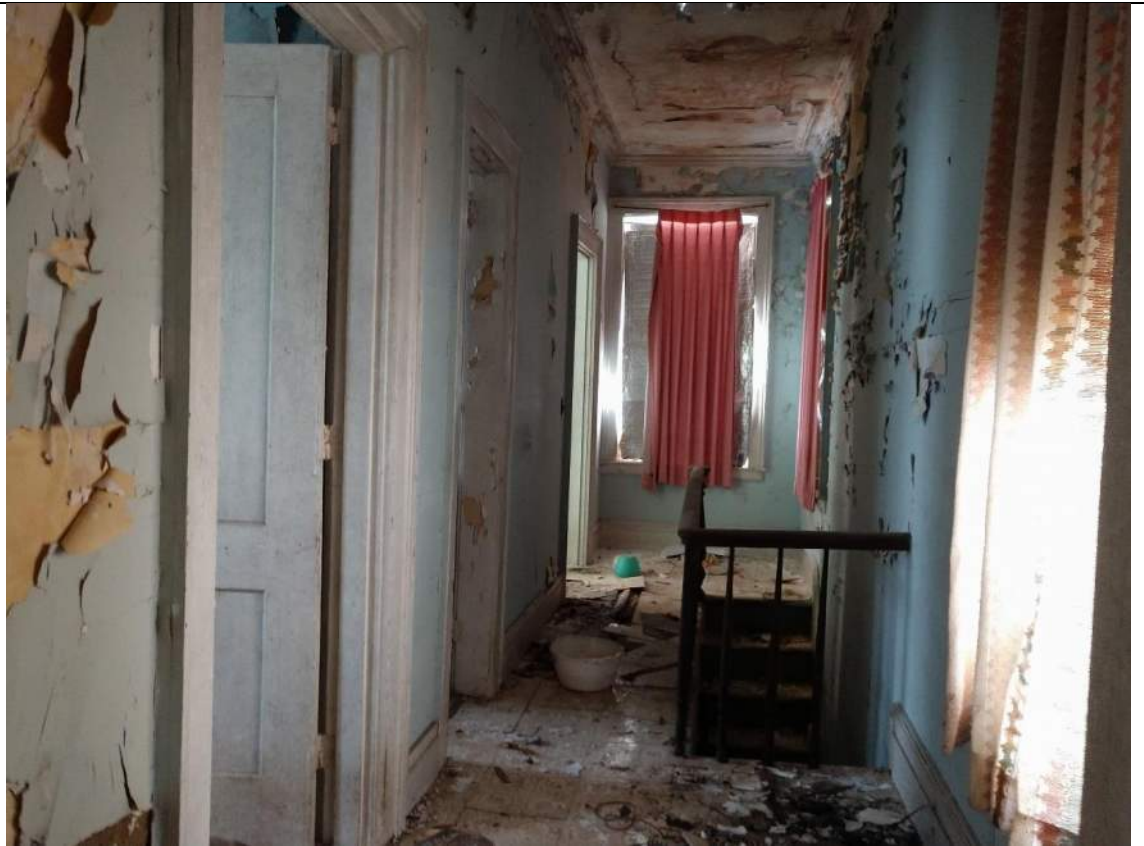
63. Hall to Rooms above kitchen, Rooms 208-206. Due to the collapsing floor, this area was too dangerous to assess.
