Re: DEC/SEQRA  
Cortlandt MOD/Evergreen Manor Development  
2003 Crompond Road, Cortlandt, Westchester County  
18PR08018

Evergreen Manor Project  
Alternative Analysis

Re: Evergreen Manor Project Specifically Former Evergreen Manor Hotel

## **Former Evergreen Manor Hotel (Photos 1- 31)**

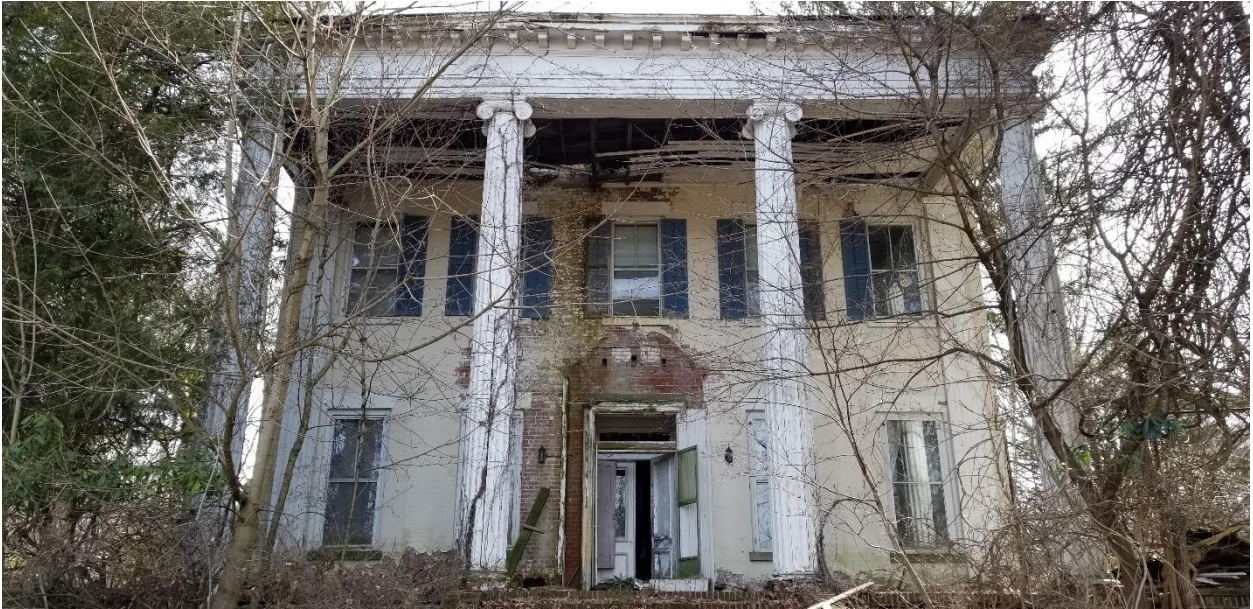
1. Front (north) elevation

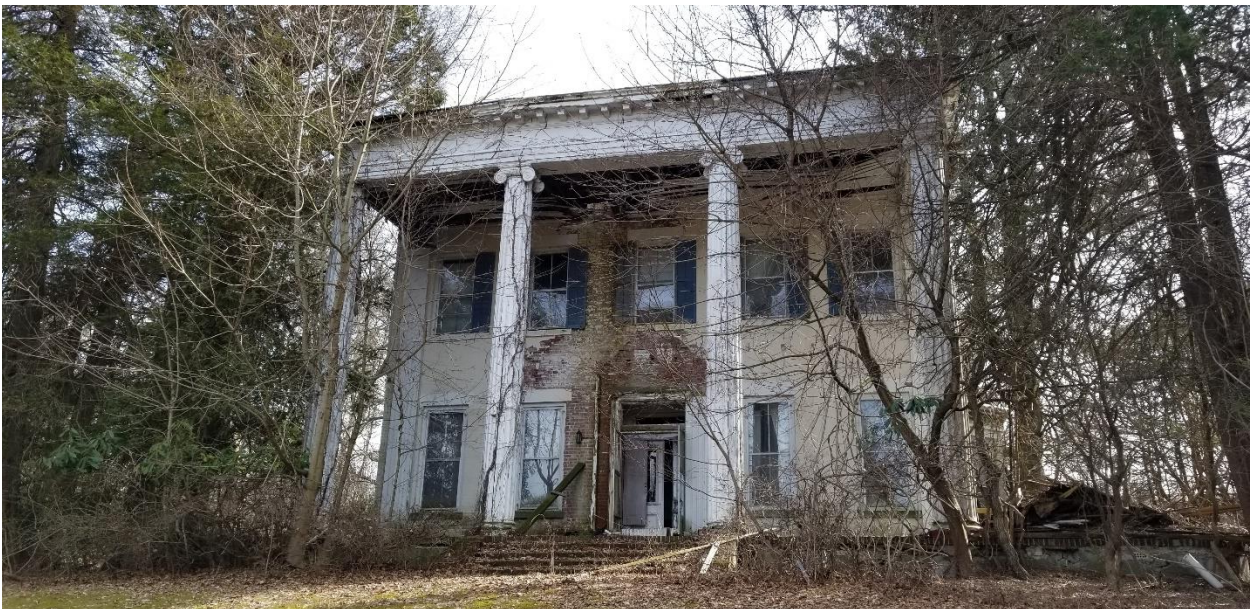
2. Front (north) elevation

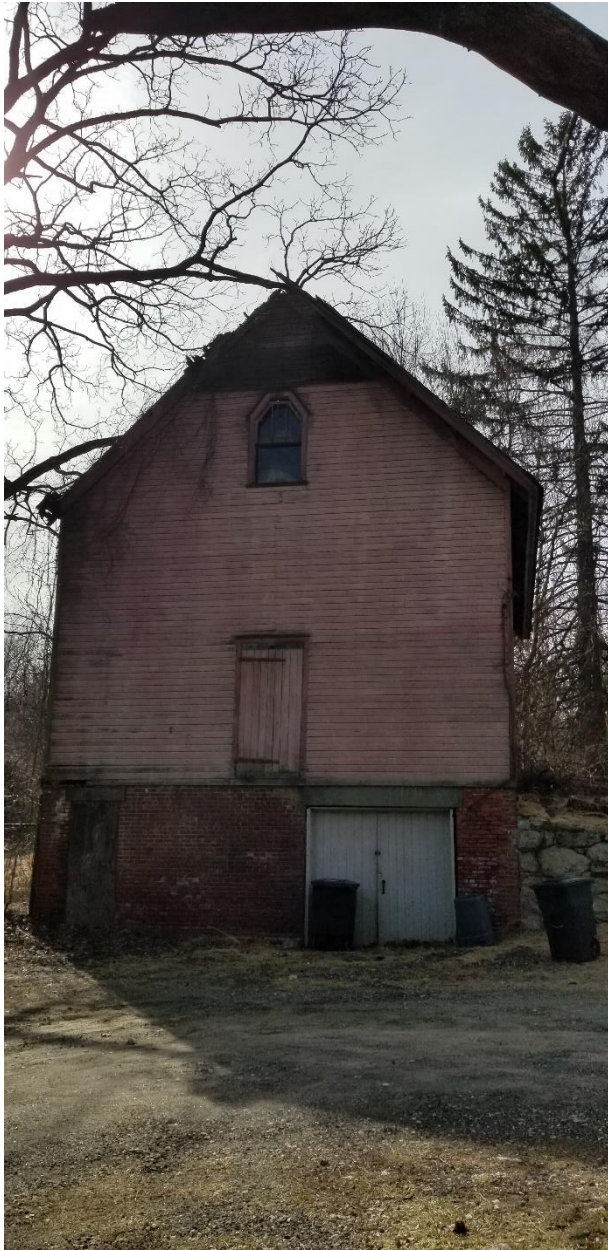
The roof is in a state of disrepair. Portions of the roof of the barn have collapsed or are missing in several sections, and the building is no longer weather tight. There is evidence of deterioration to the structural framing of the barn proximate to sections where the roof is missing. Portions of the floor have collapsed along the southern side of the building. Portions of the brick foundation have deteriorated. Due to the failures in the roofing and flooring, the structural integrity of the barn would have to be evaluated further.

32. Existing barn

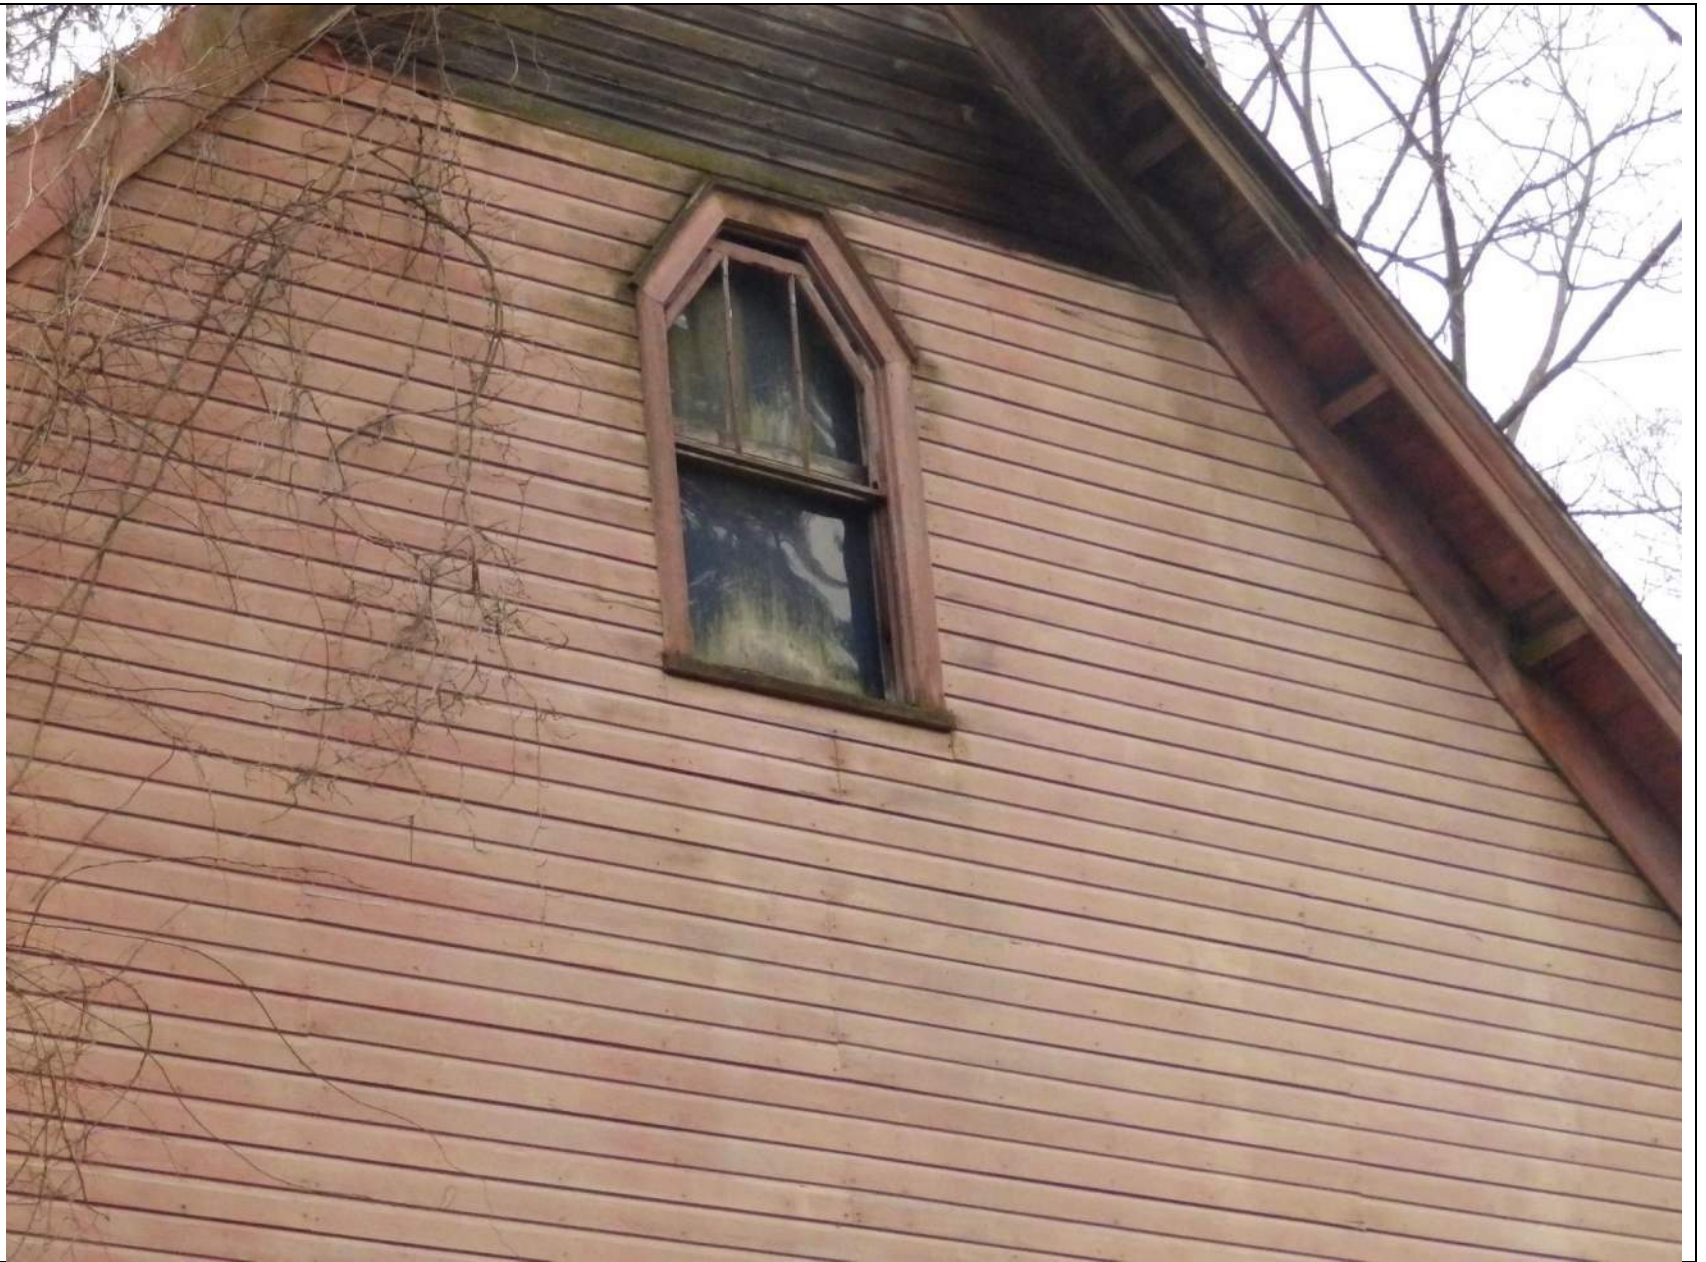
22. Pool house addition to the western side of the barn has collapsed.
